**A RESOLUTION OF THE TOWNSHIP COUNCIL OF THE TOWNSHIP OF  
VERONA DESIGNATING AND DECLARING THAT CERTAIN PROPERTY  
LOCATED AT 420 BLOOMFIELD AVENUE AND IDENTIFIED AS BLOCK  
701, LOT 3 BE DECLARED A NON-CONDEMNATION AREA IN NEED OF  
REDEVELOPMENT**

**Township of  
Verona  
420 Bloomfield  
Avenue  
Area in Need of  
Redevelopment  
Preliminary Investigation  
Report**

Date: January 2, 2026

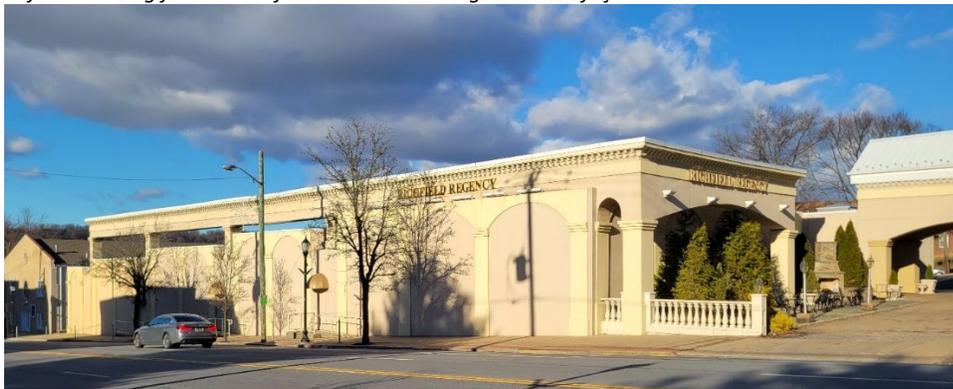
*Above Right: View of the building from Bloomfield Avenue showing the blank façade.*

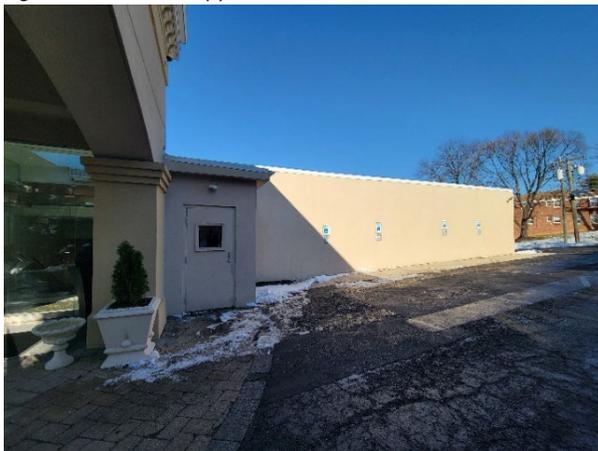
*Above: Another view of the building from Bloomfield Avenue. The main entrance of the building is along the southeasterly side of the building beneath the canopy.*

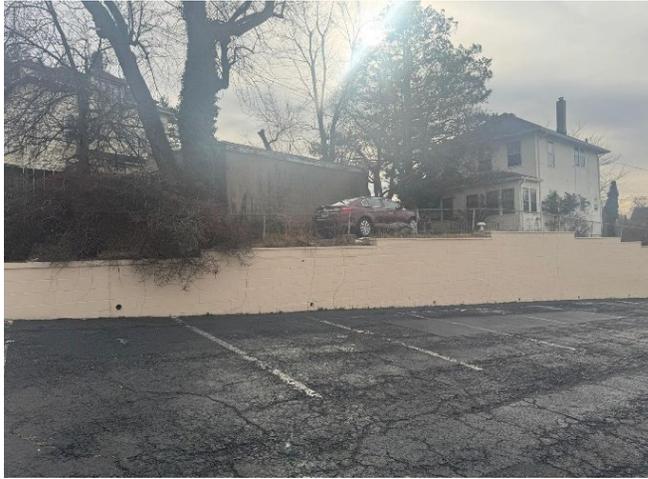
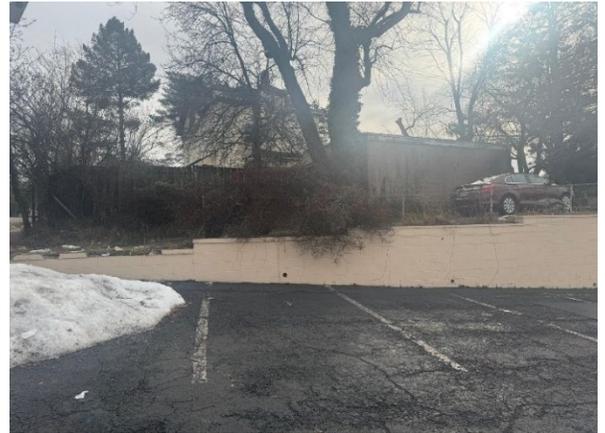
Above: View of the retaining wall along the easterly property line. There is a lack of adequate buffer to the residential use abutting the property. The residential house is at a higher elevation than the parking lot.

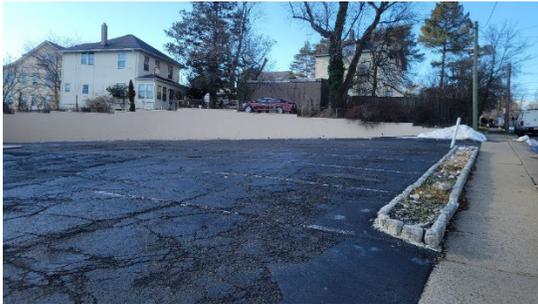
Above Left: Rear Parking lot (northeasterly side of building). Also pictured are two points of ingress and egress onto Claremont Avenue. Parking lot has cracked asphalt and undefined parking spaces.

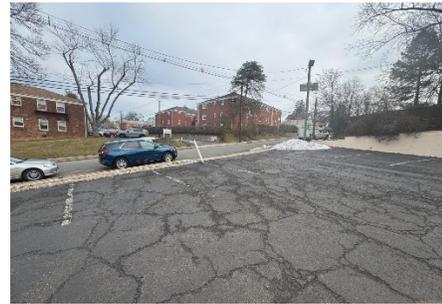
Above Right: Another view of the northeasterly side of the parking lot. The asphalt is cracked throughout the entirety of the lot, and the parking spaces lack stripping in some areas or have faded.

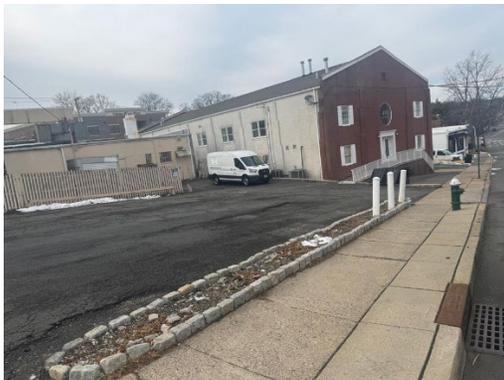
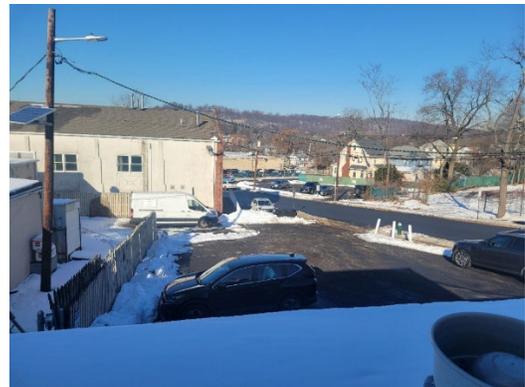
Above Left: A view of northwesterly section of the parking lot.

Above Right: View of the northwesterly side of the rear parking area from the offices. Pictured are the two points of ingress and egress from Claremont Avenue. One entrance, to the right of the photo, is partially obscured by a vehicle and snowfall. The snow-covered structure is the top of the unenclosed roof over the outdoor storage area.

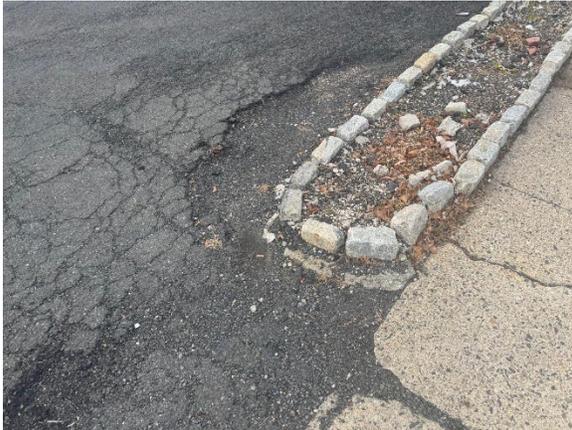
As seen in the above pictures, the parking lot is ill maintained with potholes and lack of defined parking spaces.

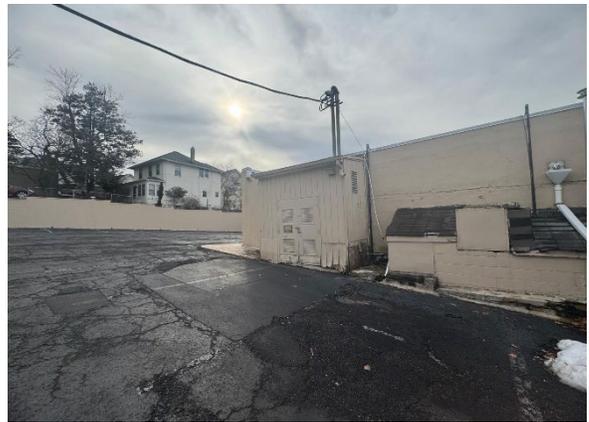
Above: View of the rear building facade. Pictured to the left is the utility shed containing high-voltage equipment and the narrow drive aisle connecting the two sides of the rear parking lot. Above right is another view of the building and the utility shed containing high-voltage equipment.

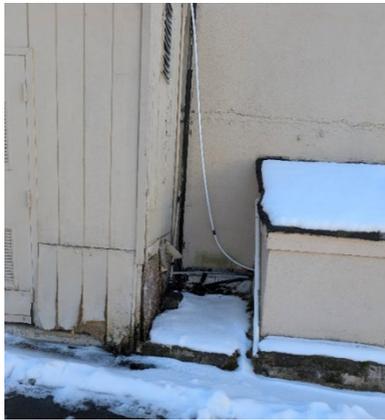
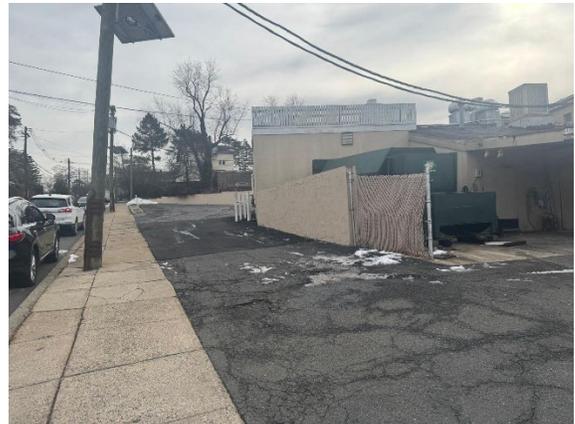
Above Left: A closeup view depicting the rotting wood and damage at the base of the utility shed storing the high voltage equipment. Above Right: A closeup view of the narrow drive-aisle that connects the two sections of the rear parking lot. The drive aisle exhibits significant wear and tear with large cracks and potholes. Also pictured is the fence-screening the trash compacter and outdoor storage/loading area from Claremont Avenue.

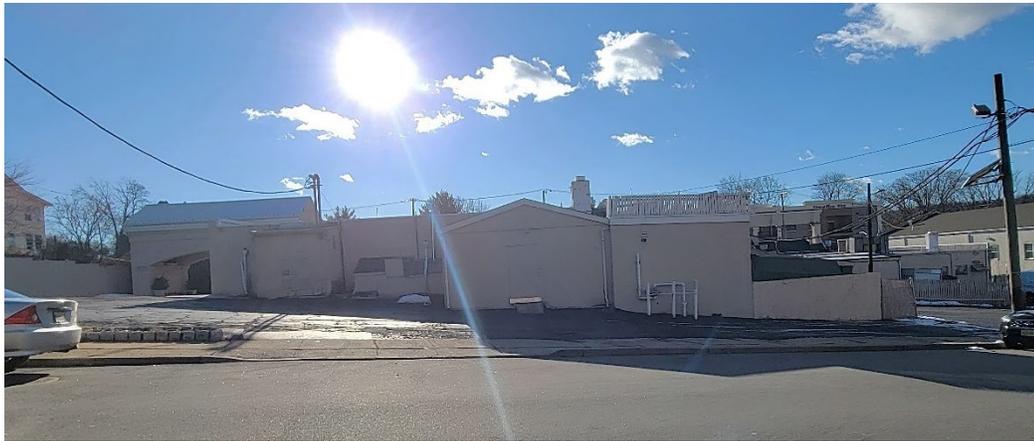
*Above: A view of the rear of the building from Claremont Avenue (northern façade). As seen above, a portion of the building projects into the rear parking lot, splitting the parking lot into two sections with a narrow drive aisle connecting the northeasterly and northwesterly sections of the parking lot.*

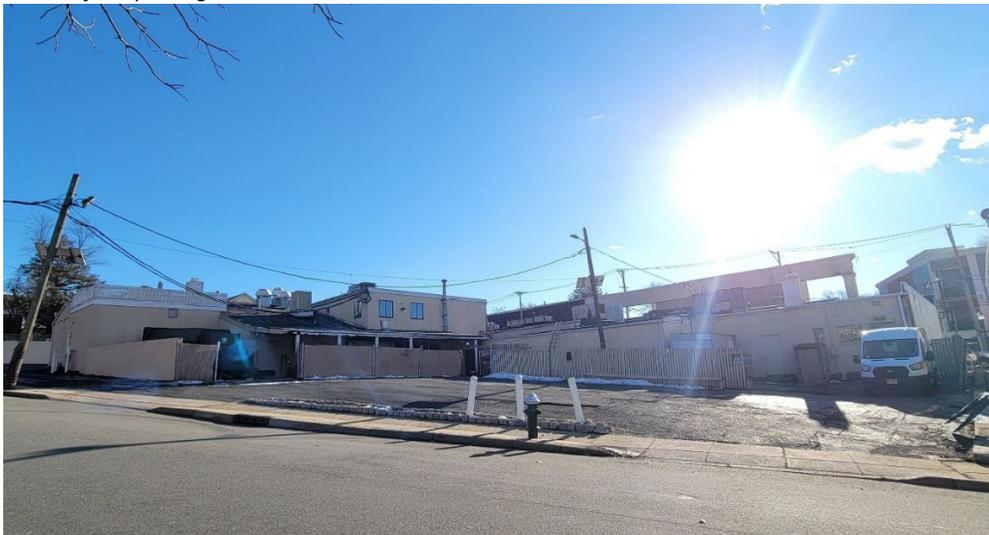
*Above: Another view of the northwesterly side of parking lot from Claremont Avenue. An outdoor trash compactor and storage/loading area against the building (left) is partially screened with a masonry wall and a chain link fence with privacy slats. A loading area and walkway (right) are screened by a fence. Also pictured are two of the four ingress and egress points along Claremont Avenue.*

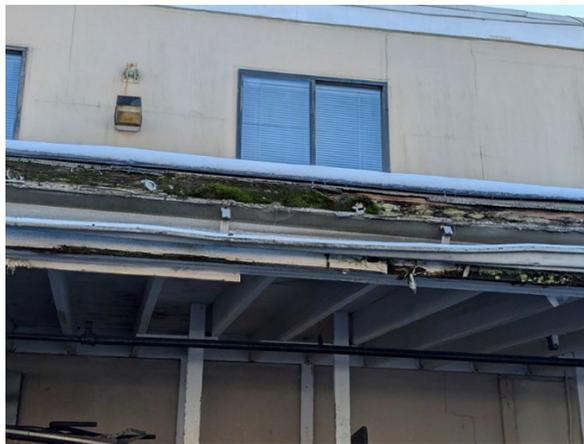
*Above Left: Close-up view of the roof above the storage and loading area. There is missing siding, and the gutters are partially detached.*

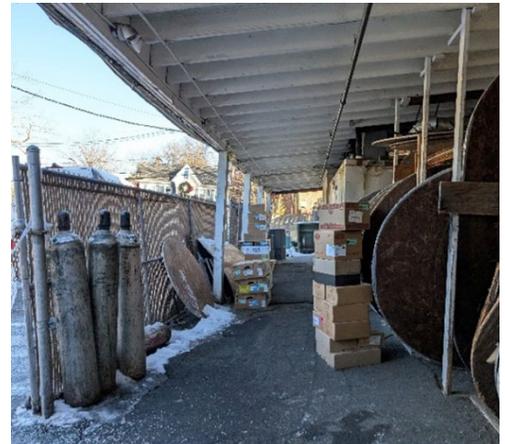
*Above Right: View of the rear outdoor storage area under the unenclosed roof and behind the fence. Discarded items and boxes are piled up to the roof, obstructing the walkway leading to the trash compactor and exterior.*

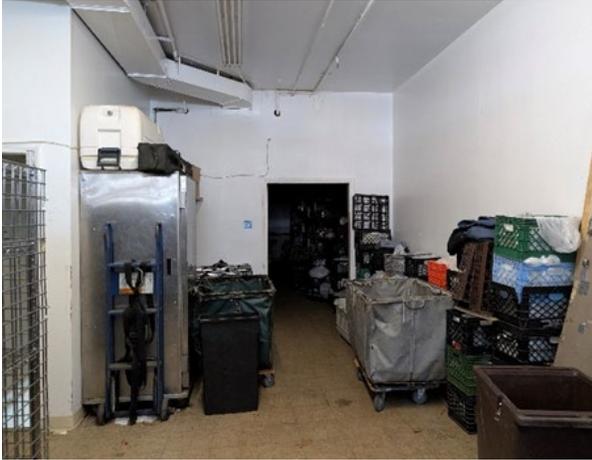
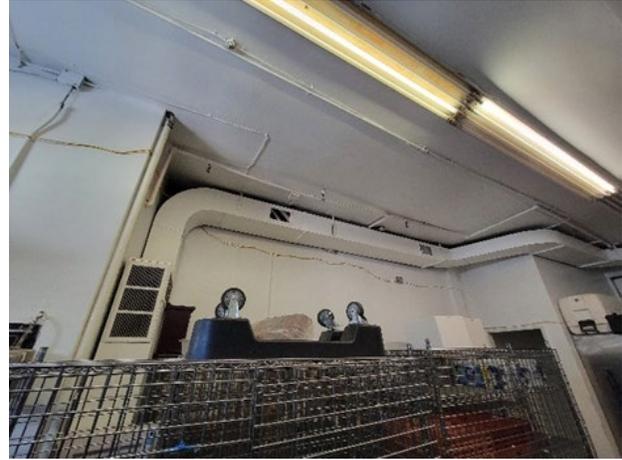
Above: View (left and right) of an interior storage area, located on the ground floor towards the rear of the building. According to the property owner, items in this storage area are still used by staff.

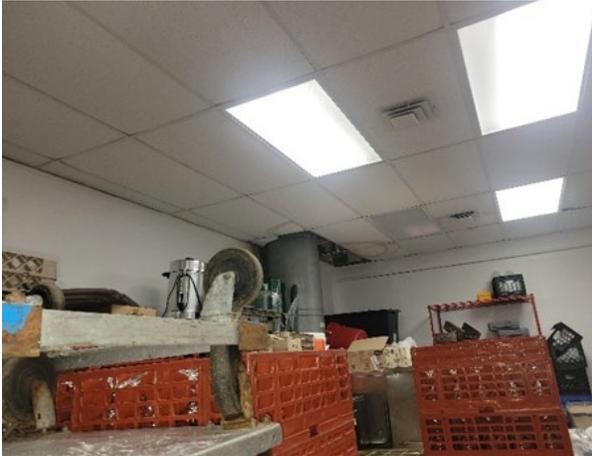
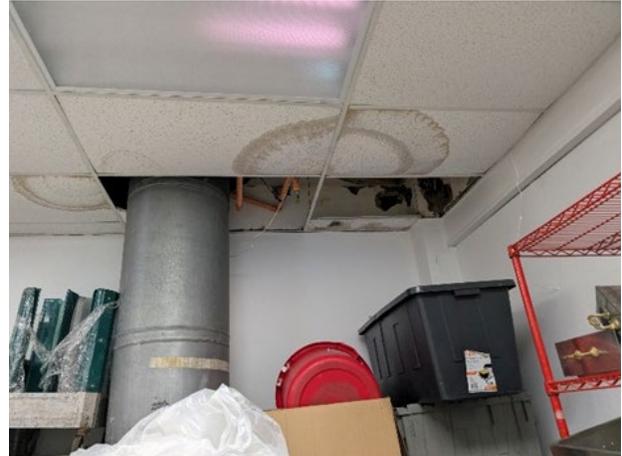
Above Left: Another view of ground floor storage area. Above Right: A closeup view of the ceiling in the ground floor storage area with missing tiles. Water stains show water damage probably from roof leakage.

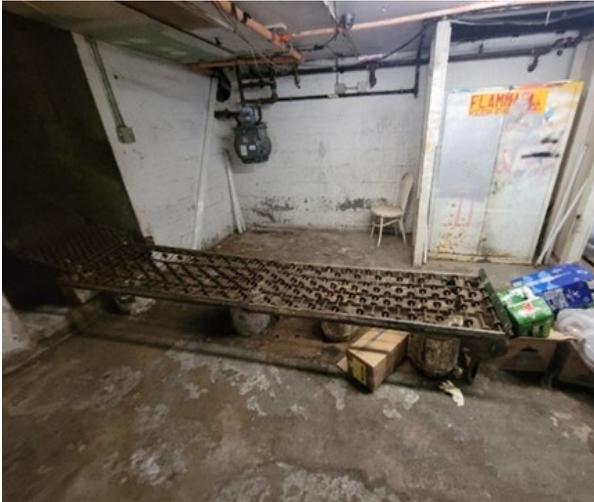
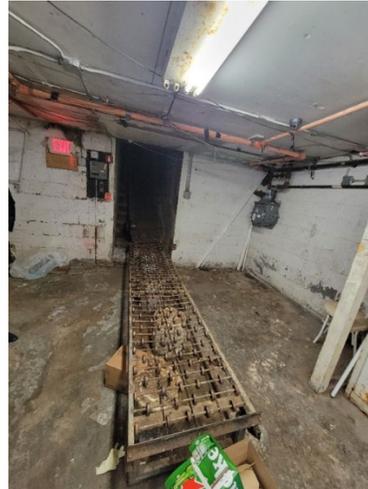
Left: View of the basement loading area. An old skate-wheel conveyor resting on buckets, is used to bring items indoors from a stairway that leads outside, to the rear of the building. There is wear and tear to the floors and to the cabinet used to store flammable items.

Right: A close-up of the loading area in the basement.

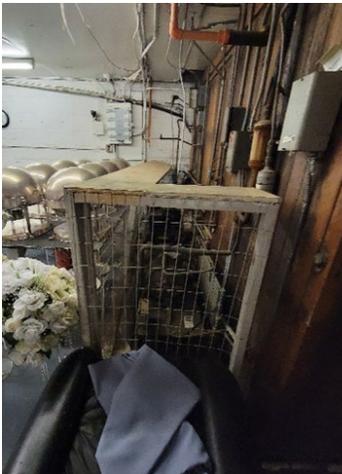
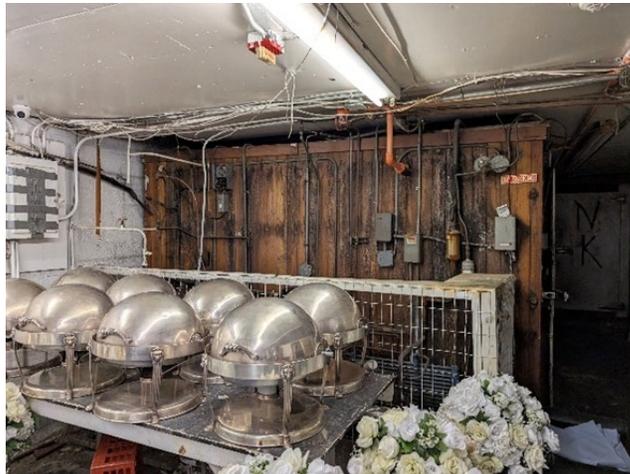
View of a built-in freezer from the 1960s (left) and close-up view of its motor (right). Property owner informed H2M that this freezer is no longer functional and is used for storage (bottom left). Also pictured (bottom right), in the hallway in this part of the basement where there are two more non-functional freezer/refrigerators that are currently used for beverage storage.

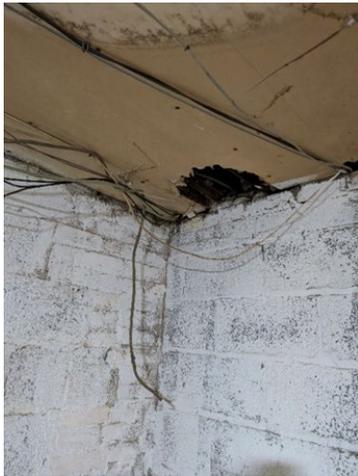
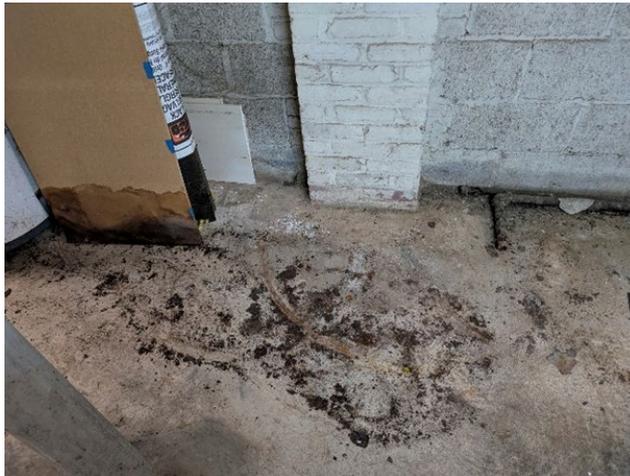
*Above Left: View of rough, patchwork repair on the ceiling in the basement. Above Right: In addition to a large hole and exposed wiring, this area exhibits staining and possible mold from water infiltration. Also pictured (below left), in a separate area within the basement, water stains along at the base of the walls which are indicative of water infiltration.*

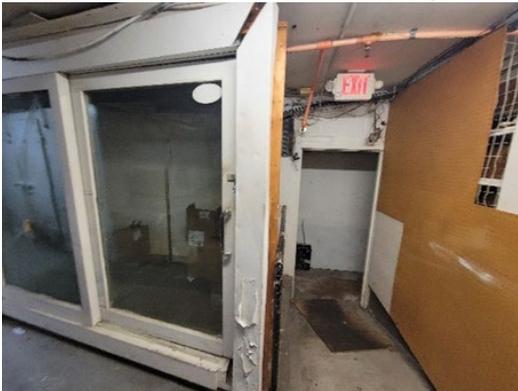
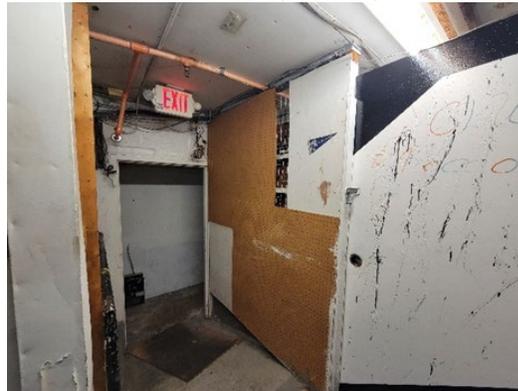
*Above left: View of a non-functional freezer (left) in basement and a hallway leading to a service entrance to an upstairs ballroom. As per the property owner, this service entrance is not being used.*

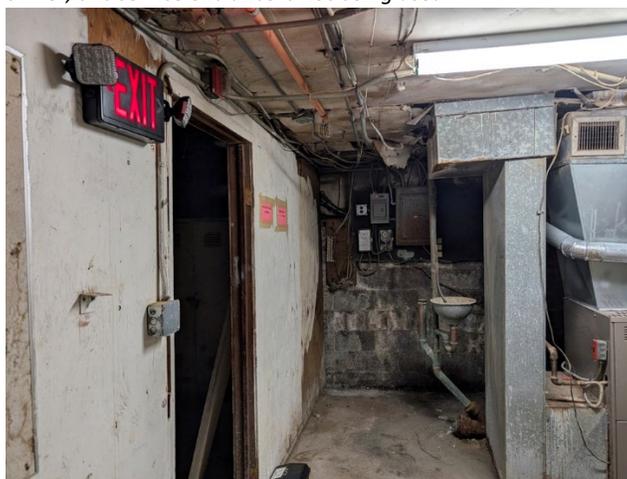
*Pictured above is the entrance to a storage room in the basement. Peeling and warped ceiling tiles, water staining, exposed wiring, and aging plumbing indicate obsolescence and lack of maintenance.*

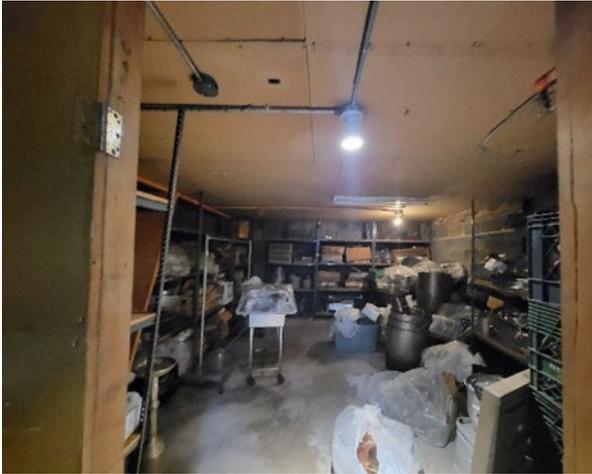
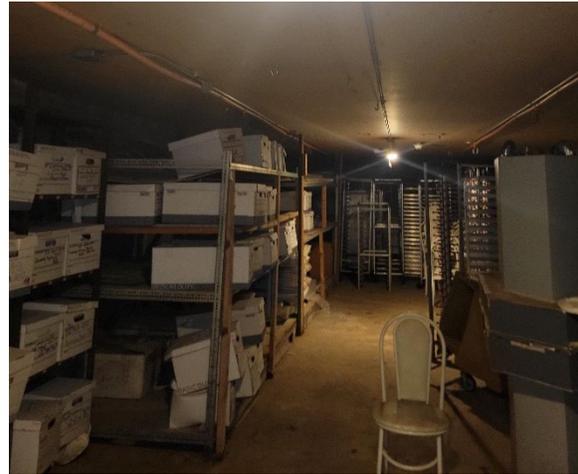
View of separate storages rooms in the basement (above left and above right). As per the property owner, the storage rooms are for old, discarded items. Old equipment and other items are also being stored in hallways (below left and below right).

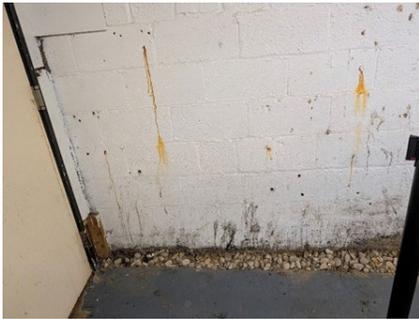
*Above Left: View of the basement floor. The gap between the foundation and concrete floor in this area is filled with stones and dirt.*

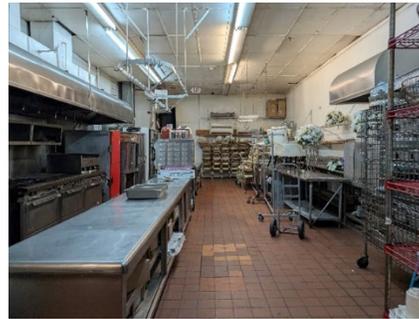
*Above Right: A view of the basement kitchen. Although the equipment and working areas are in good condition, there is evidence of a lack of maintenance and wear and tear, particularly with the floors and ceiling.*

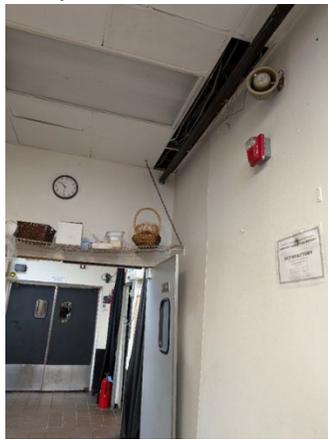
*A view of the entrance to the kitchen is pictured above. Ceiling tiles are missing and show exposed wiring.*

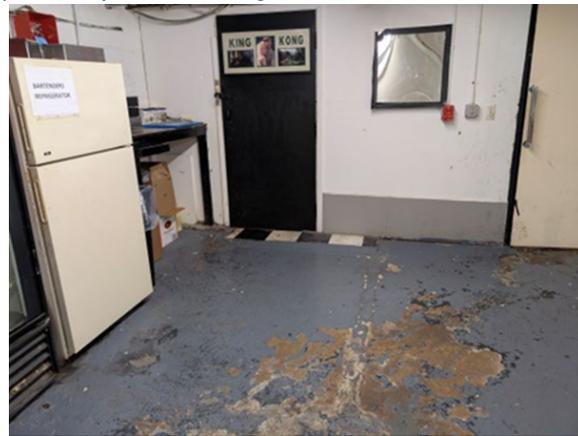
*A view of the kitchen space with bartender's refrigerator exhibiting wear and tear on the concrete flooring.*

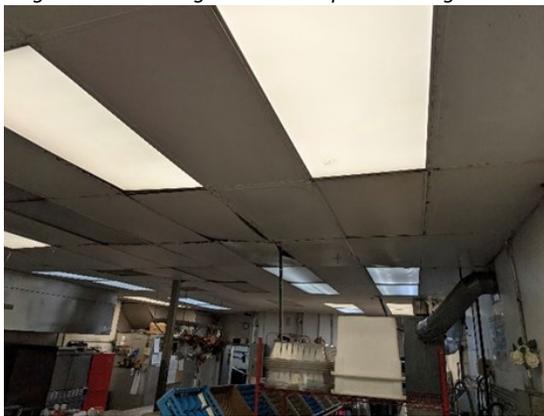
*A close-up view of the water damaged, warped ceiling tiles in the kitchen.*

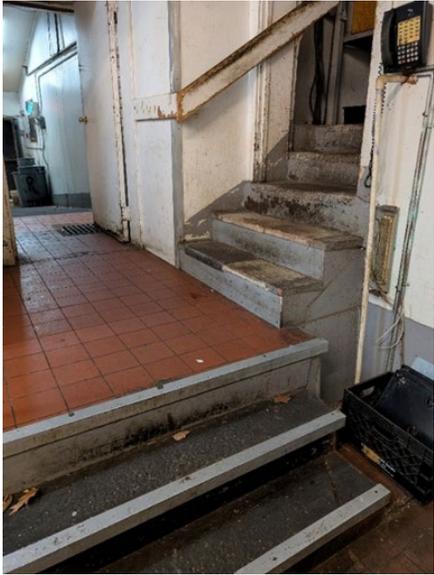
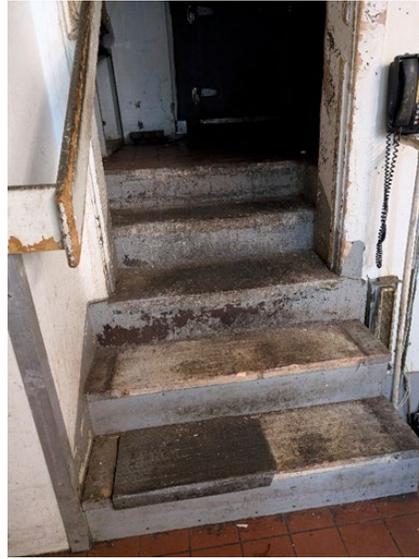
*A view of the staircase leading from the kitchen to the upper level. Stairs are missing tiles and show significant wear and tear.*

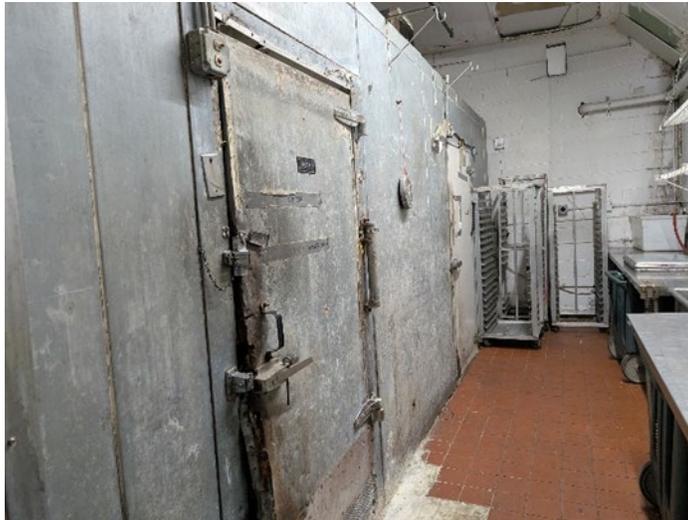
*A view of a non-functional built-in deep freezer within the kitchen. The floor around the freezer has missing tiles.*

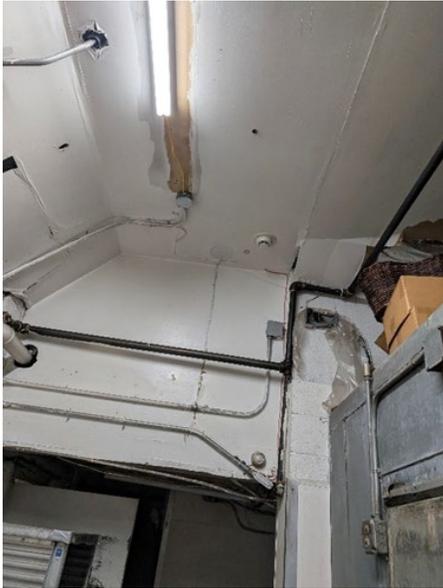
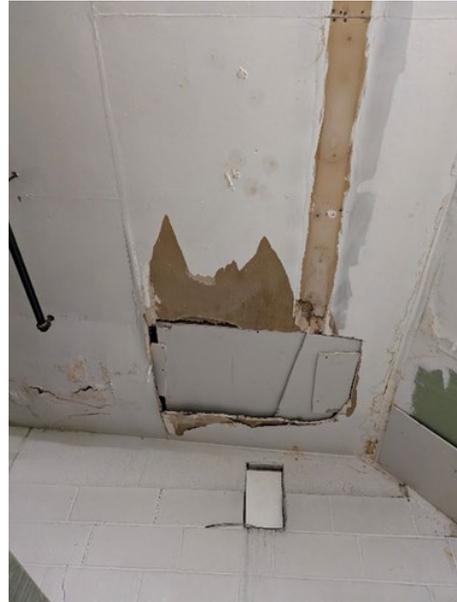
*A view of the ceiling above the non-functional freezer pictured above. A hole in the ceiling is covered by a make-shift patch.*

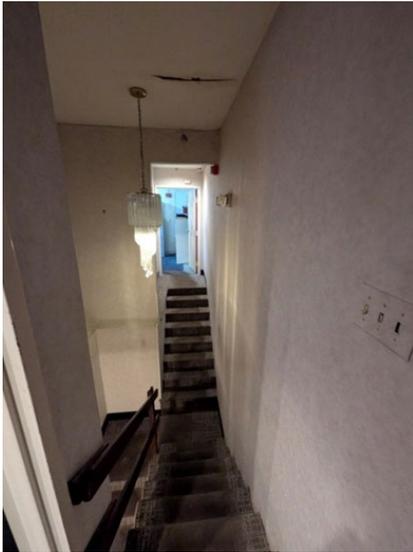
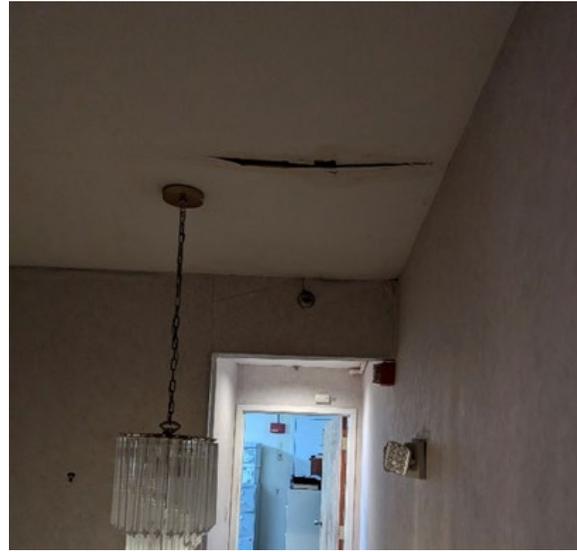
*A view of the stairway leading from the ballrooms on the ground floor to the offices at the upper level (left). A close-up view of the water damage from the leaking roof can be seen (right).*

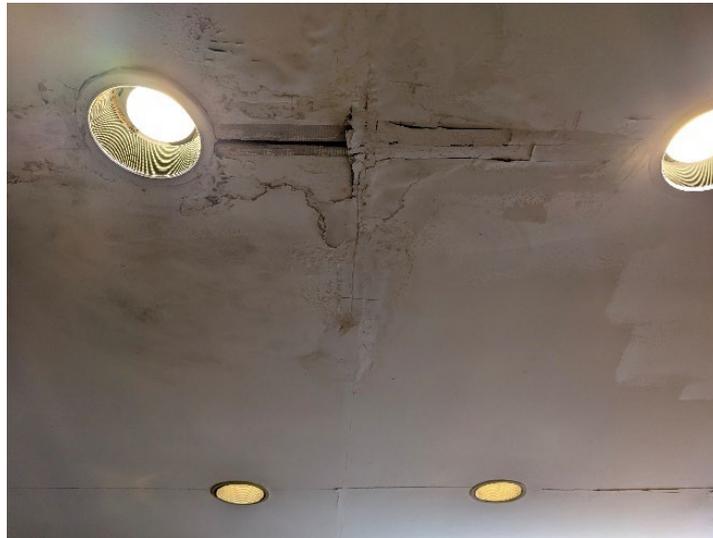
*Water damage from the leaking roof is more evident in the offices that are on the upper floor. Seen above is water damage and warped ceiling tiles in the main office.*

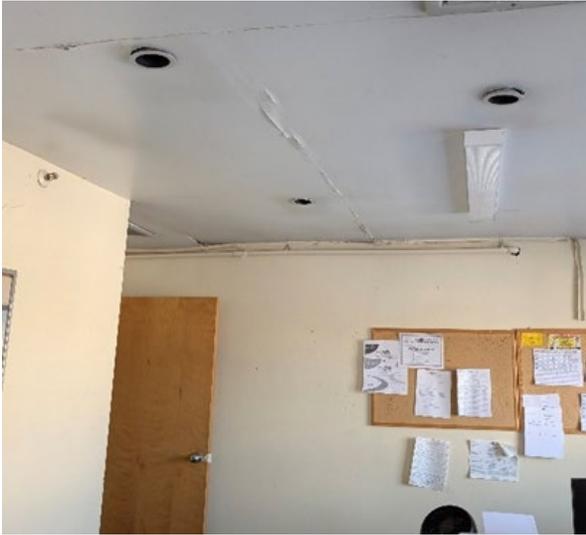
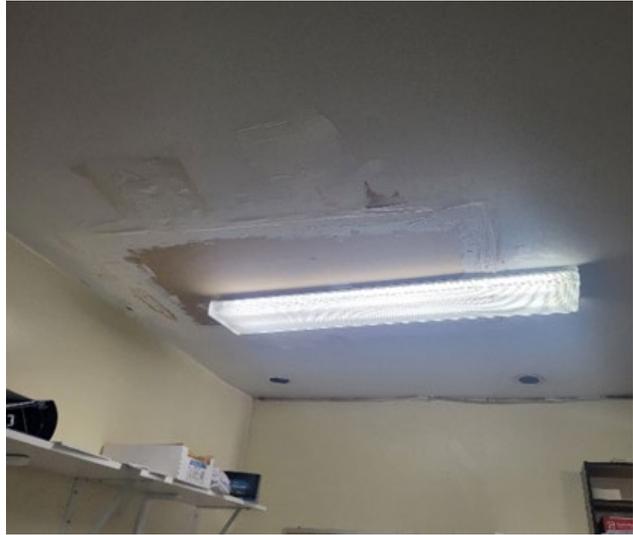
*A view of warped drop ceiling tiles in an office (left). Another office space with patched ceiling and water stains from roof leaks (right).*

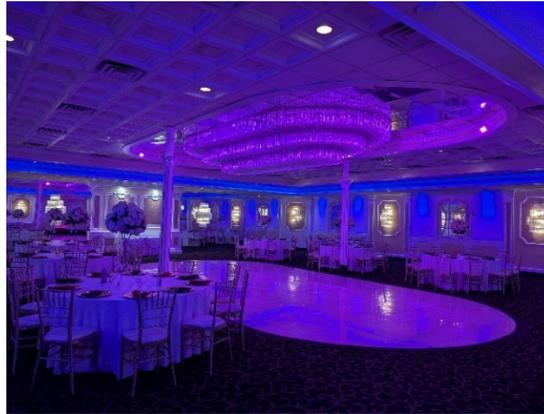
View of "Gold Room" ballroom with decorative lighting. Although room appears to be in good condition, water damage and wear and tear are apparent upon close inspection.

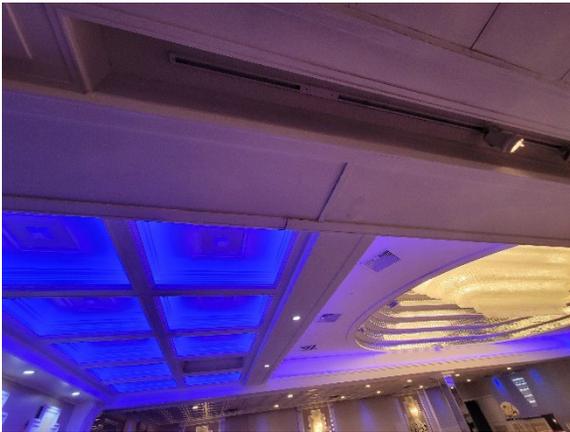
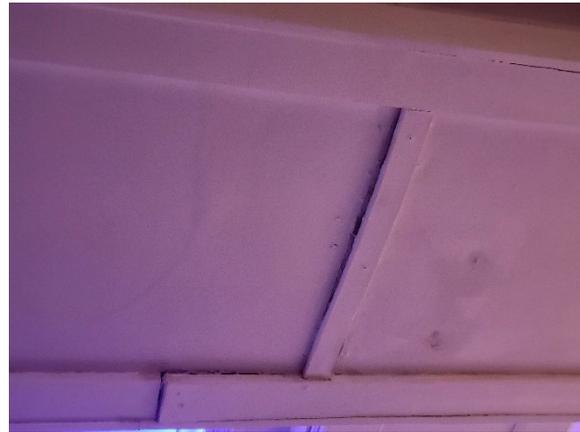
Above Left: View of the ceiling. Above Right: Closeup view of the ceiling in Gold Room where water damage from roof leakage has been patched and painted over.

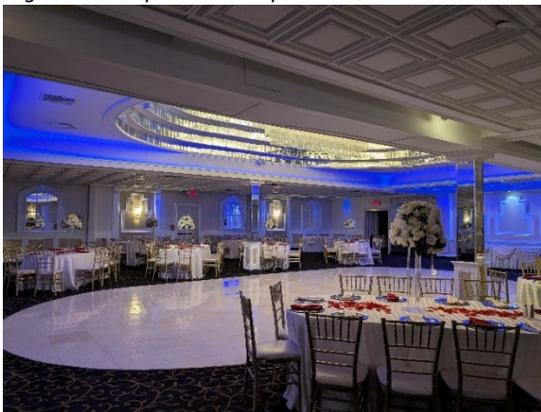
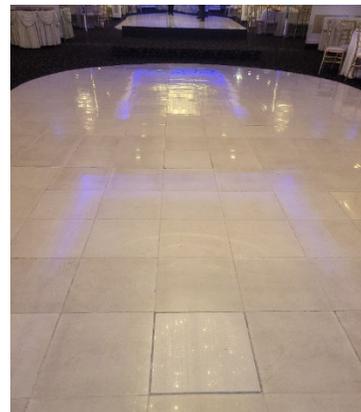
View of the "Regency Room" ballroom with decorative lighting (left). Like the Gold Room, the room appears to be well maintained but exhibits water damage and wear and tear that is apparent upon close inspection. Pictured above (right) are the room's uneven dance floor tiles.

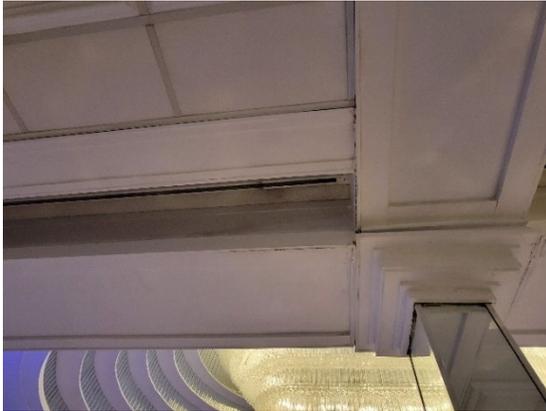
*A view of the ceiling and pillar in Regency Room showing warping and water damage from roof leaks that have been painted over to hide it.*

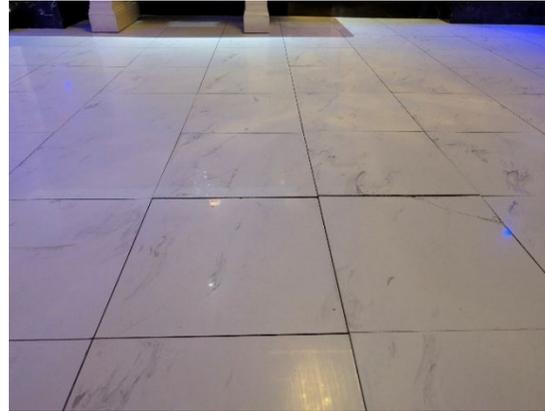
*View of the lounge on lower level (below ballrooms). As reported by the property owner, the uneven tiles are due to uplift from water infiltration and frequent repairs.*

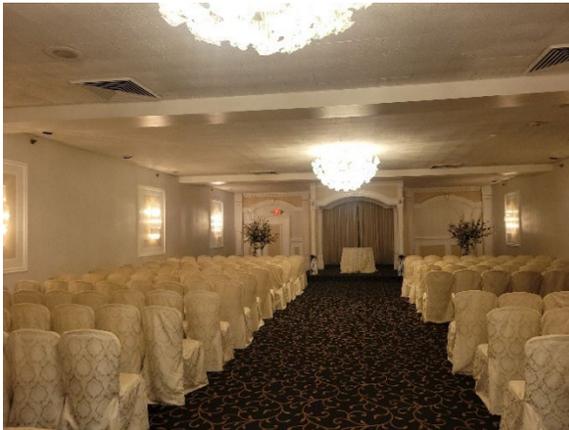
*View of chapel room with dated décor and wall to wall carpeting.*

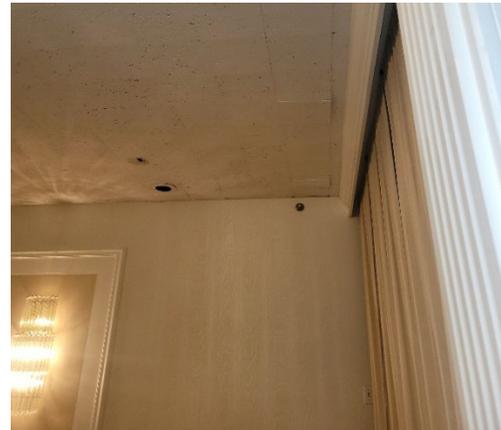
*A closeup of the warped drop ceiling tile in the chapel on ground floor of building. Although frequently patched, as per the property owner, water infiltration is also an issue in this room.*
