STERLING OPERA HOUSE
COMPREHENSIVE STUDY

PROGRESS UPDATE

FEBRUARY 9, 2026

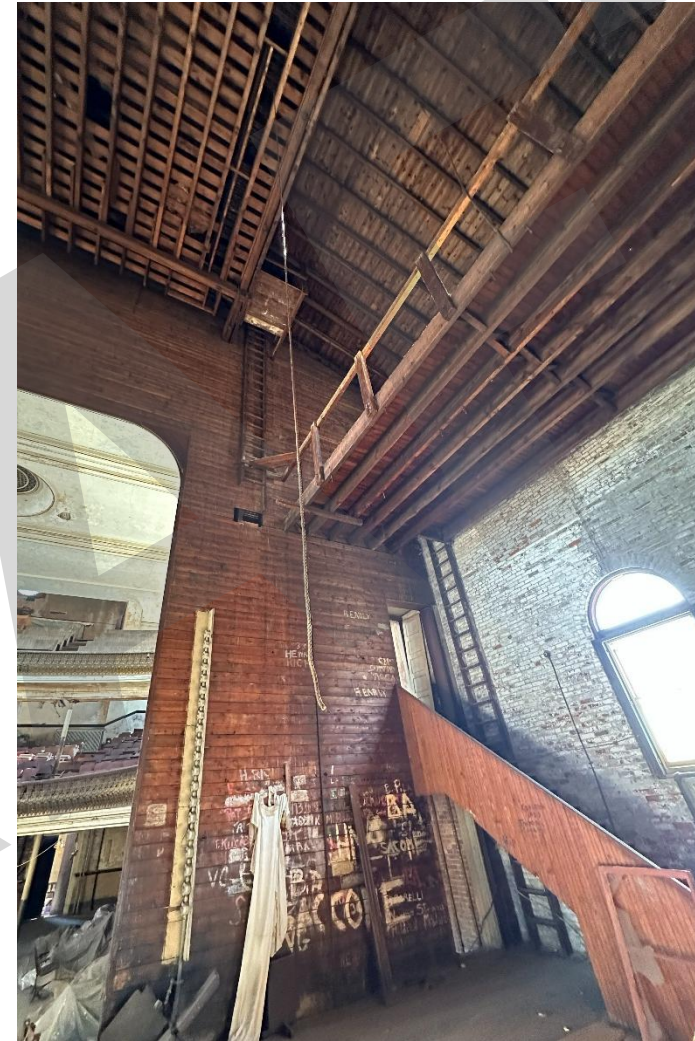
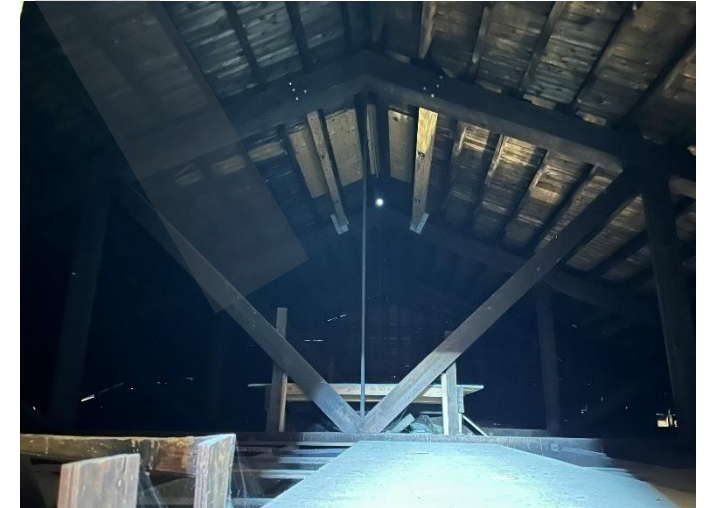
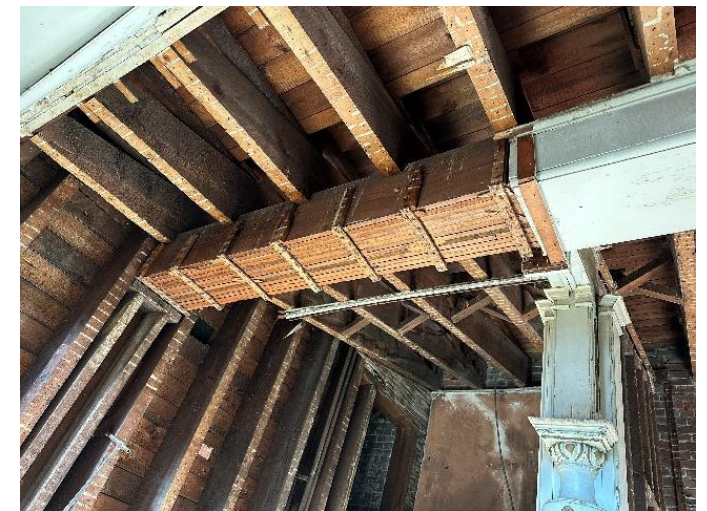
The focus of the structural investigation was to determine primary framing type, location, and representative sizes for major areas, neglecting local details. Bearing walls were identified and viewed in general; these walls did not exhibit obvious deficiencies, noting that they were not thoroughly examined. Much of the wood framing in the building was exposed and was observed to be in generally good condition exhibiting very few checks, splits, twists, corrosion, etc.

Most of the wood was exposed because of prior removals of plaster and similar finished surfaces.

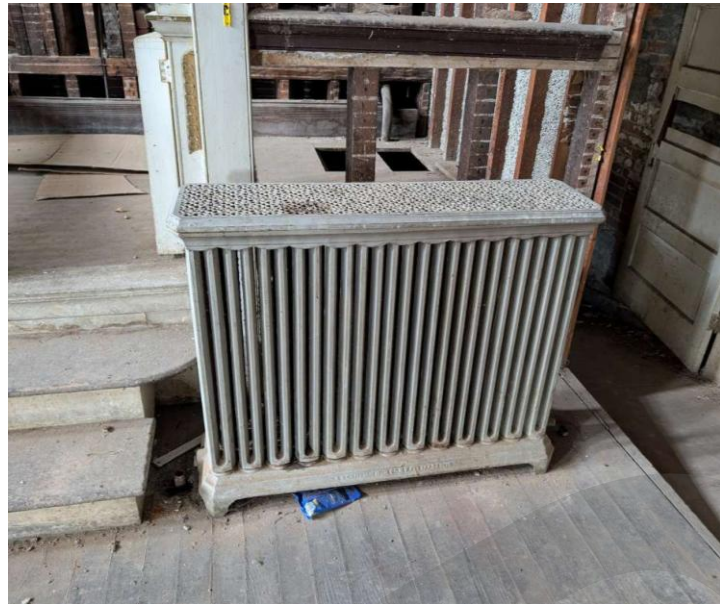
Fig. 5

The building does not appear to have any forced air ventilation. We assume that the heating was provided by steam or hot water, based on the presence of radiators within occupied areas (Fig. 5). Natural ventilation through windows and the attic void (Fig. 6) appears to be the traditional approach for cooling, and was likely satisfactory to audiences of the past century and neighbors who were not subjected to highly amplified performances. Modern comfort standards and the higher sound levels of today's amplified events will most likely lead the team to recommend some form of forced air cooling system with ducted fresh air intake and exhaust. Locating the equipment for these systems - most likely two or more air handlers plus chillers, pumps, and cooling towers - is an acoustical challenge. To the extent possible, these systems are best located in the basement or at grade and mounted on spring and neoprene vibration isolators.

It is clear that some large fan equipment and potentially a chiller will be located above the stagehouse in a new mechanical area. It will be essential that this new equipment space is constructed with a concrete slab and equipment located there is mounted on vibration isolation. Equipment mounted to upper floors of the building will prove more difficult to isolate and may transmit noise and vibration over a broad area of spaces. Therefore, we also recommend selection of quieter models for equipment – well-balanced air handlers with thickly insulated casing and chillers with mag-lev bearing or substantial external isolation like 3-inch static deflection spring and neoprene mounts. Mechanical areas, particularly those above the stagehouse, will also benefit from approximately 50% coverage of their ceiling with a 2-inch thick mineral wool plenum board. This added sound absorption will help prevent airborne noise generated by equipment from propagating to occupied spaces that are nearby.

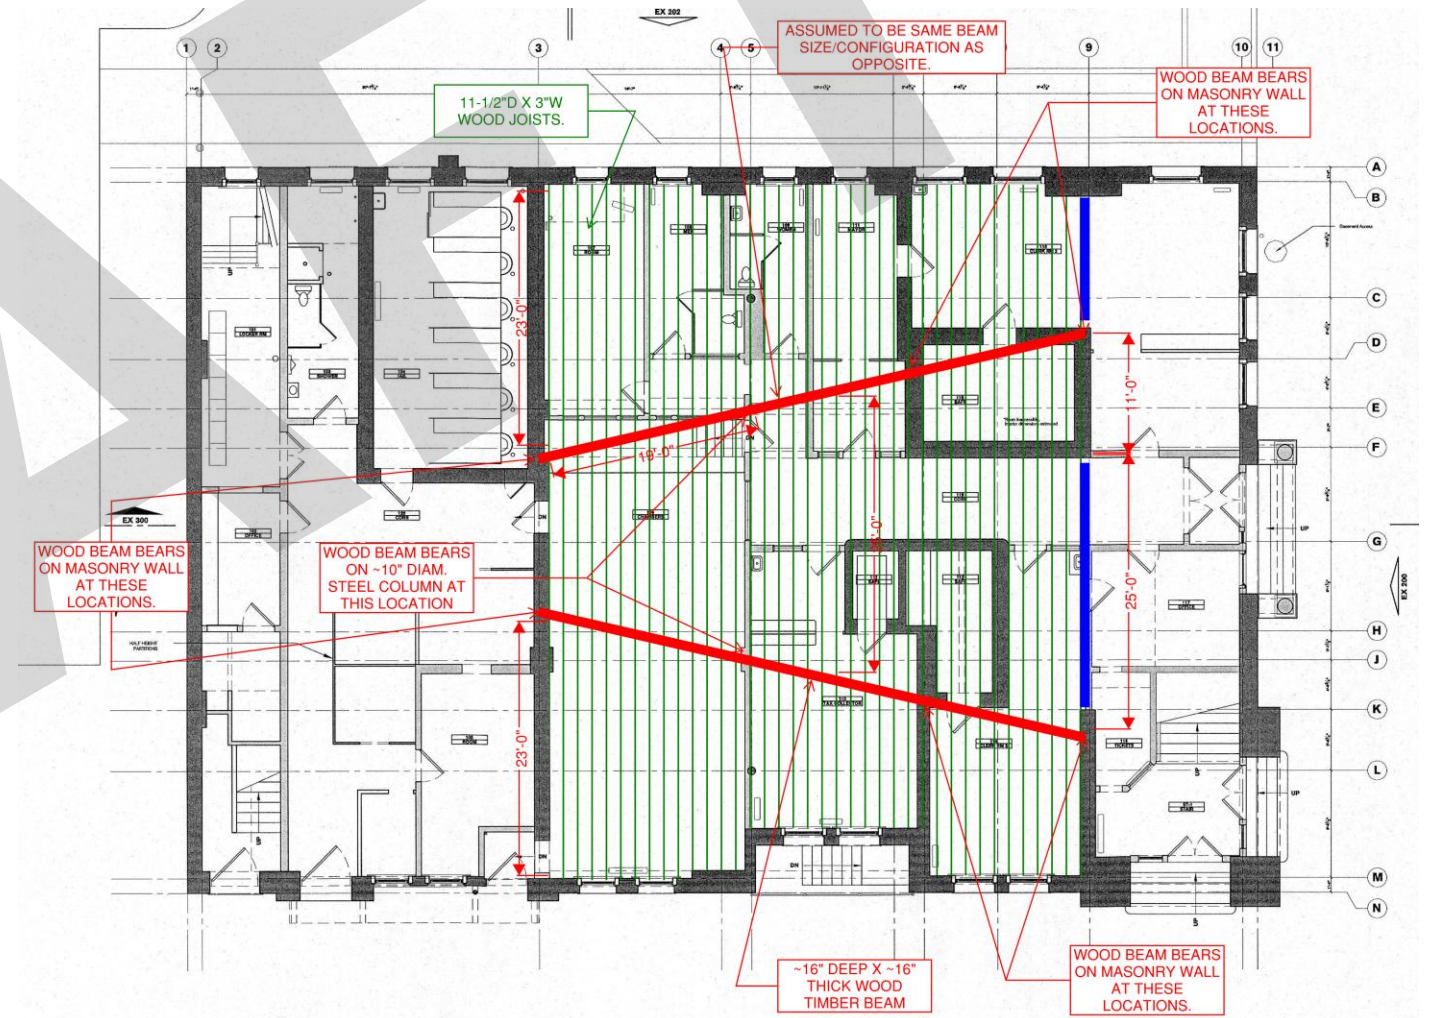
Joists exceeding 19' span are overloaded with public assembly, whereas joist exceeding 21'-6" span are overloaded with fixed seats. This overload pertains to high stresses and excessive deflections. The overloaded joists could be supported by local bearing walls or transfer beams, or they could be reinforced. Reinforcing could consist of side steel flitch plates or LVL wood side plates and through bolts installed along 60% to 70% of the length of each overloaded joist.

The wood girders are notably overloaded under public assembly load, whereas one of the three spans of each girder is overloaded with fixed seats. Like the joists, the girders can be reinforced with steel or LVL side plates along most of the length of the girder.

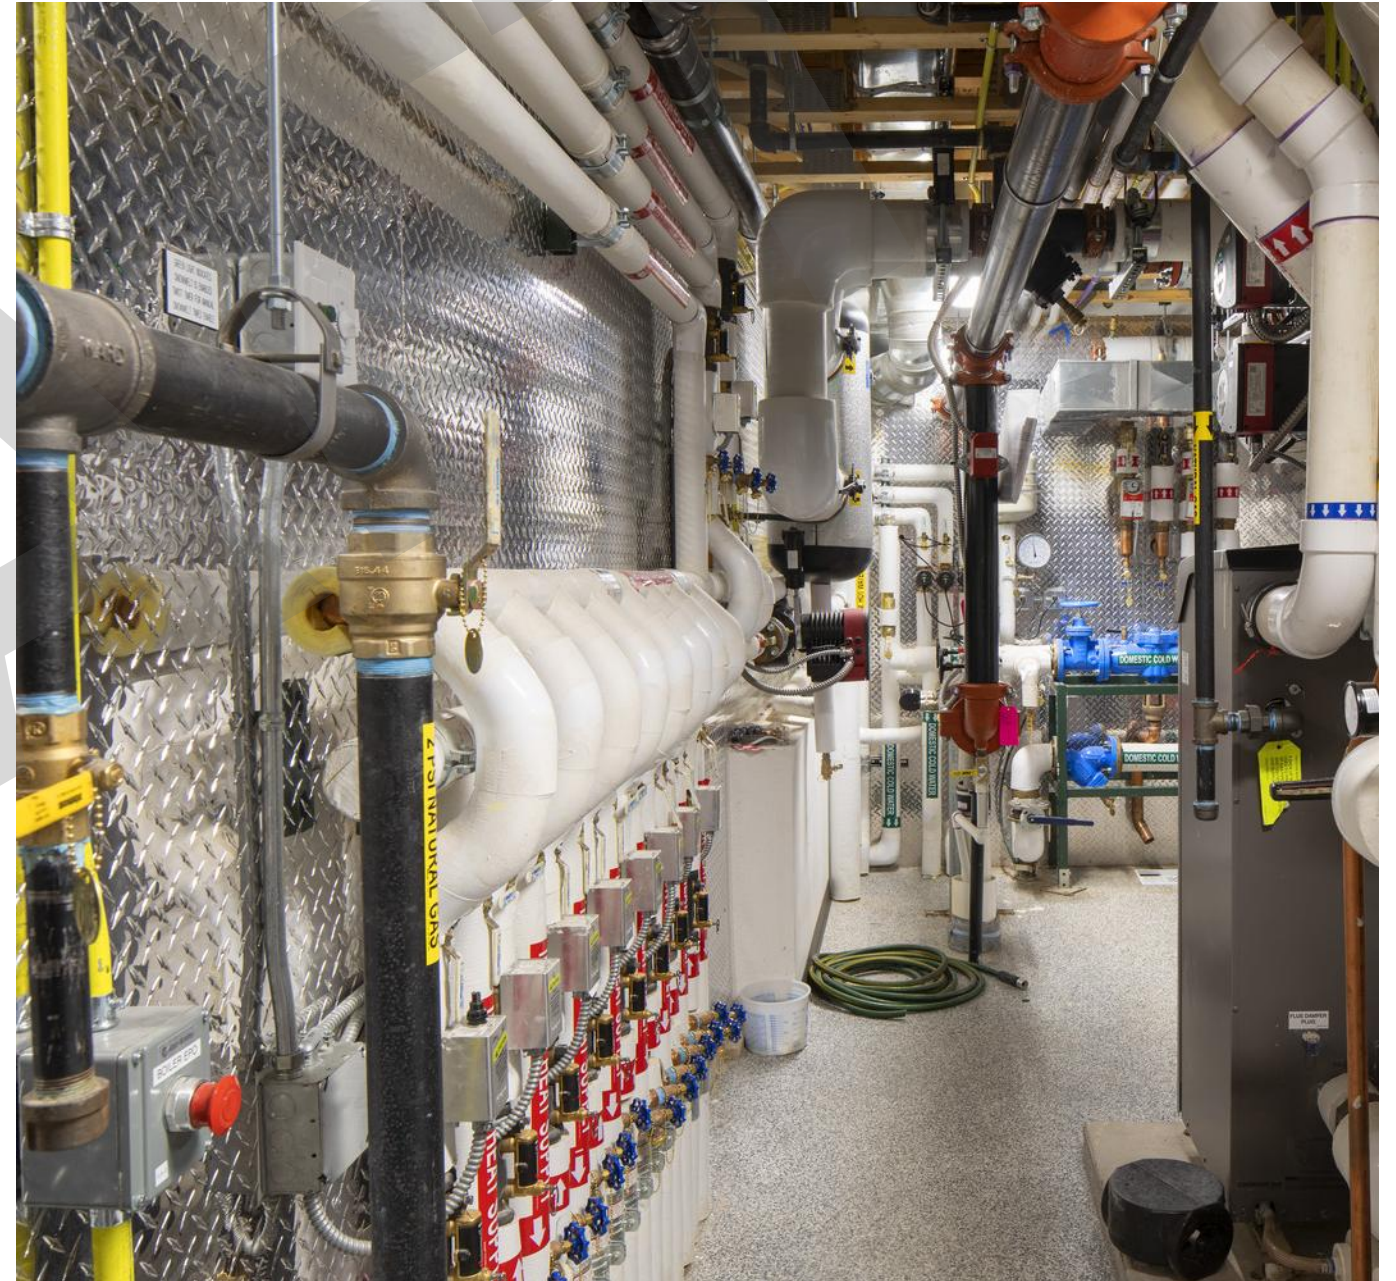
- The existing water service entrance appears to be galvanized steel piping. The existing service entrance and valves likely contain materials with unacceptable lead content and shall be replaced. Service piping should be replaced with new from the existing service main in Elizabeth Street.

- All existing sanitary system piping shall be removed and new piping installed as required by the new program. The existing connection at the Elizabeth Street sewer line should be scoped to verify conditions and replaced with new as required.

- The existing exposed storm piping should be scoped and inspected to confirm conditions and replaced as required. Existing south side storm system will be rerouted as required with the new addition installation.

- All existing plumbing fixtures shall be removed and new fixtures installed as required by the new program.
- Interior vent piping should be scoped and inspected to confirm conditions and replaced as required. Existing vent piping through roof to be reused.

- Domestic hot water will be generated through electric water heaters with circulation to remote plumbing fixtures. Below stage fixtures will be supplied from dedicated electric tank located in the janitor's closet. The street level restrooms, upper-level concessions and Balcony restrooms hot water will be supplied from an electric tank located in the street level janitor's closet. Alternately, remote area concessions and Balcony two restrooms will be provided tankless electric units as required by the program.
