Iowa County- Health and Human Services Building

# Iowa County- Health and Human Services Facility

## Facility Condition Review

DRAFT Report January 16, 2023

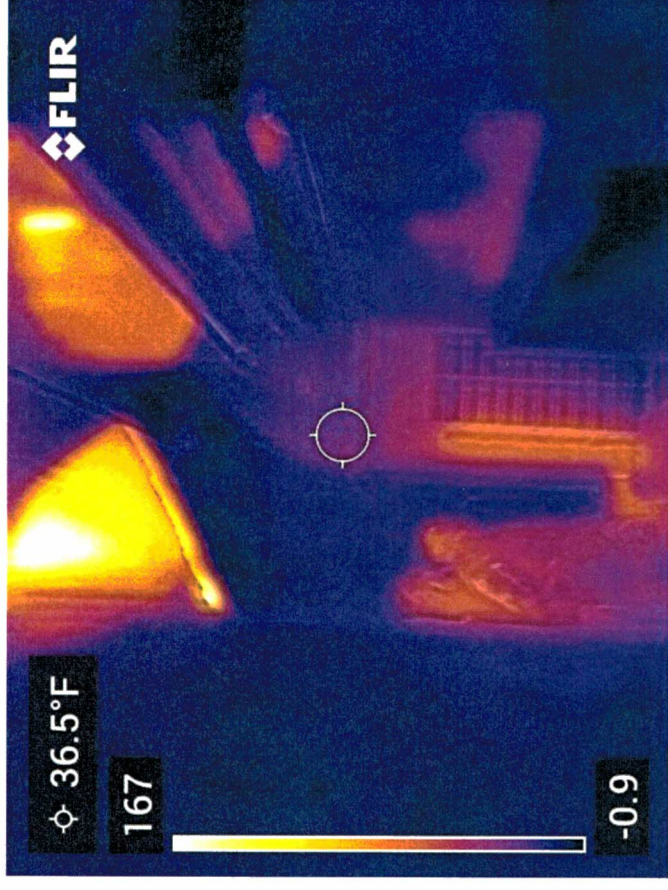
# Thermal images

- Image is of VRV system, unit heater and duct work in penthouse
- Temperature scale: -0.9 degrees F to 167 Degrees F
- Unit heater directed at VRV, blowing hot air onto unit
- Temperature across the coil was measured
  - Range from 11 degrees F to 91 degrees F
- This range across the coil is not recommended
- Not conducive to good operational control

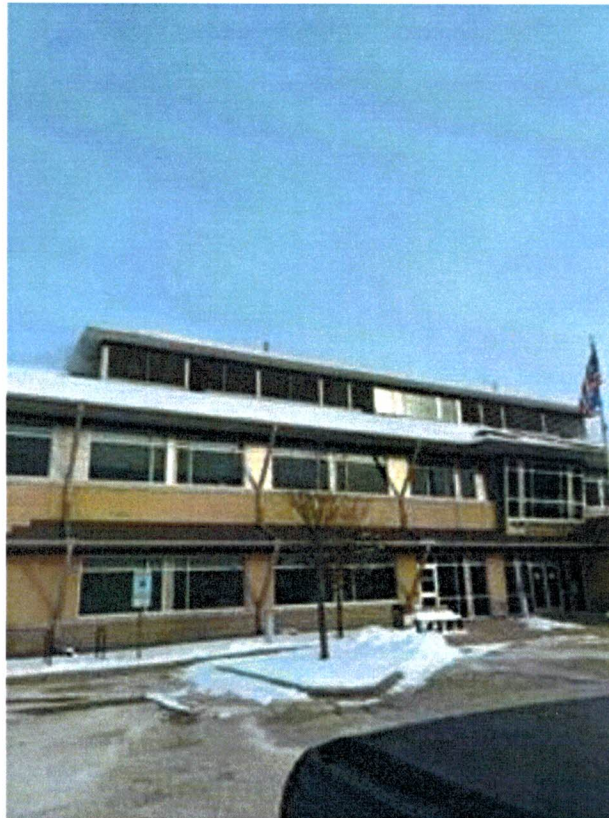
**Figure 1.** Exterior photo showing penthouses and intake louvers.

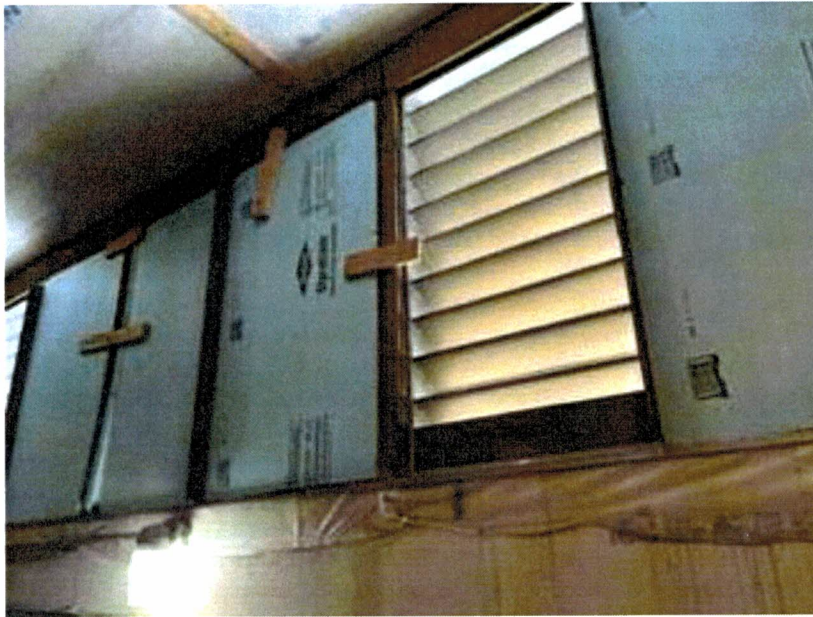
**Figure 2.** Intake louver in the penthouse. Note that portions of the intake louver have rigid insulation blocking sections of louver off.

The only issue regarding the exterior enclosure for moderation of temperature is stemmed by the design of the penthouse. It is recommended that modulated control of the louvers via mechanical dampers will better maintain the penthouse temperature, reduce the need for the unit heaters to operate, therefore will save energy for the facility. The mechanical damper control system is included in our estimates and recommendations.

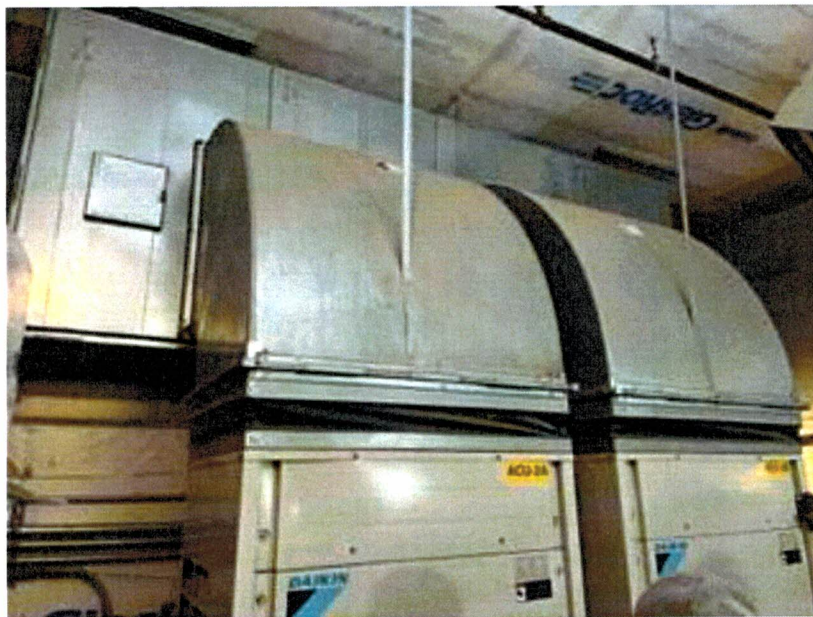
**Figure 3.** Discharge air from VRV condensers ducted to exhaust plenum and louver.

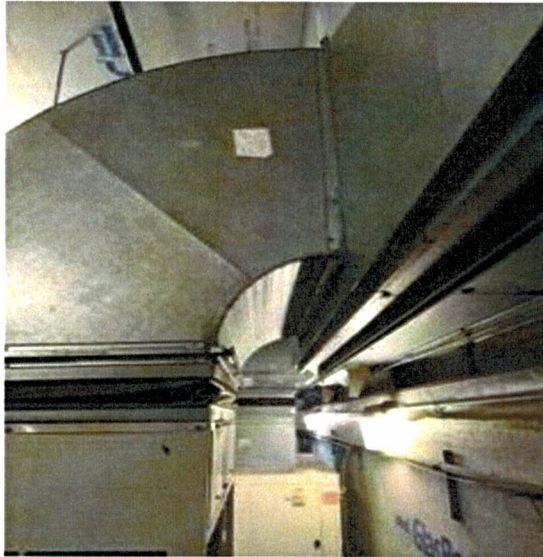
**Figure 4.** VRV condensers discharge is located in a common exhaust plenum.

1. It is recommended that each VRV condenser be individually ducted all the way to the building exterior. If VRV condenser discharge is connected to a common plenum, then short cycling could occur which would impact performance of the condenser.
2. It is recommended to install motorized dampers on the outdoor air and two motorized dampers on the discharge from the VRV condensers. On the discharge duct, one damper should direct air to the exterior of the building and one should recirculate air back to the penthouse.

2. The existing gas fired unit heaters can be used to help maintain temperature in the penthouse after the new dampers are installed. Discharge from the unit heaters should be modified to prevent potential "false" readings of the outdoor sensor on the Daikin units. Adding some distribution ductwork would also be beneficial to distribute warm air more uniformly throughout the penthouses.
3. To prevent potential short cycling of discharge air from the VRV condensers, each condenser should be individually ducted to the building exterior per Daikin sales representative recommendation.

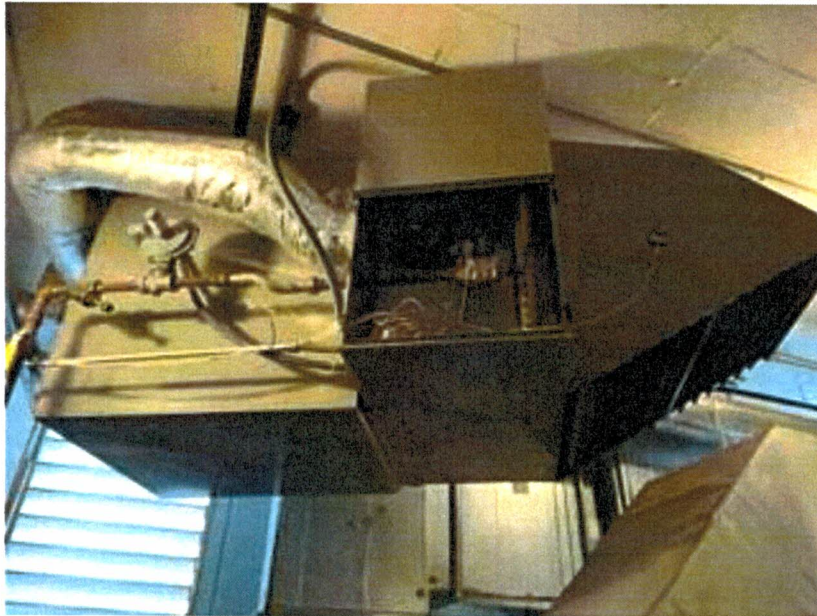
**Figure 5.** Gas fired unit heater installed near top of penthouse with discharge air directed down toward VRV condensers. (On the day of our visit, the shown Unit Heater was not operational).

3. It is recommended to not have the unit heater discharge air directed down directly onto the VRV condensers. Potentially this configuration could “false load” the VRV condenser actual outdoor air sensor in the unit into staying in the cooling mode and locking out the heating mode. At 75 degrees F as sensed by this sensor heating mode is locked out and the unit stays in cooling mode.

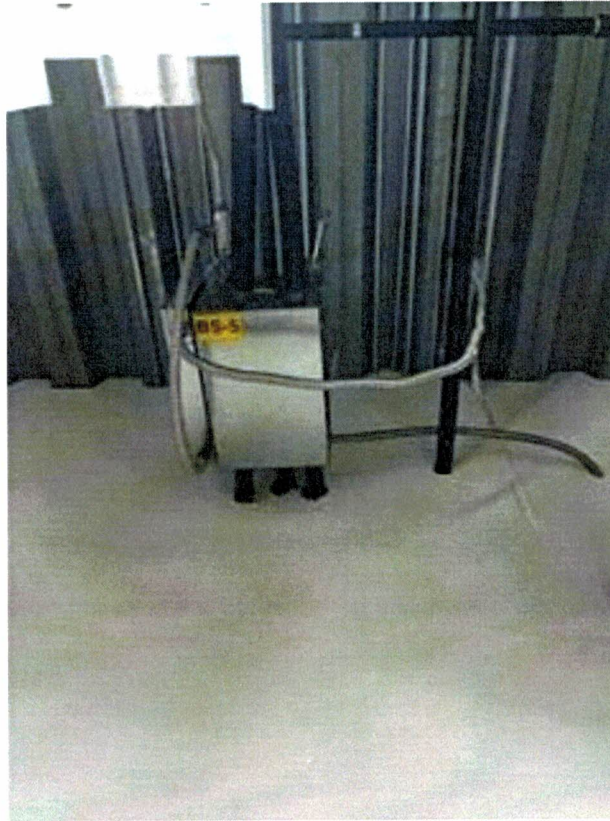
**Figure 6.** Typical building selector unit for distribution of refrigerant piping to terminal units.

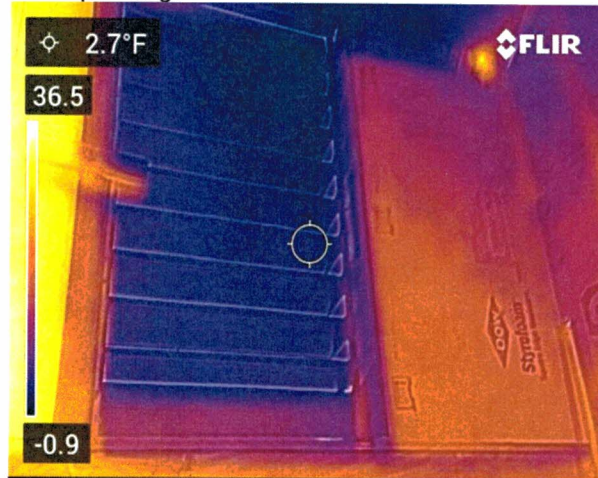
**Figure 7.** Thermal image of an intake louver opening. Note temperature at open louver. Warmer temperature on rigid insulation that is blanking off louver.

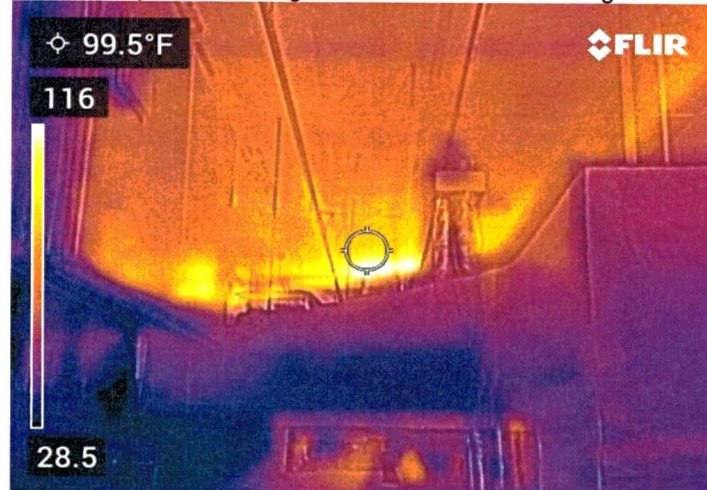
**Figure 8.** Thermal image of a penthouse showing warm air at top of penthouse and cold air down toward the floor of the penthouse

1. There is a non-uniform temperature profile across the penthouses. Warmer air is present at the top of the penthouse and much cooler air near the floor. Also colder temperatures are seen farther away from the heater.
2. The VRV condensers have non uniform air temperatures across their coils.
3. The combination of cold air and non-uniform temperature profiles on VRV condensers is impacting performance of the system in the heating mode.

1. In order to allow the VRV condensers to operate correctly, the penthouse temperature needs to be uniform and stable above at least 40 degrees F minimum. To accomplish uniform and stable temperature it is recommended to add motorized dampers to the outside air intake louver and two dampers in the discharge from the VRV condensers. One damper in the discharge would recirculate air back to the penthouse and the other damper would exhaust air to the outside. Below are two graphics for damper placement:

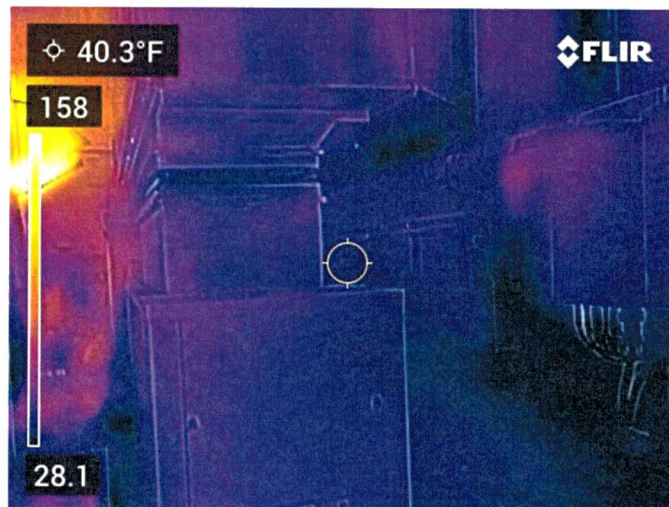
**Figure 9.** Thermal image showing hot air discharging from unit heater and cold temperatures in the penthouse further away from unit heater discharge.

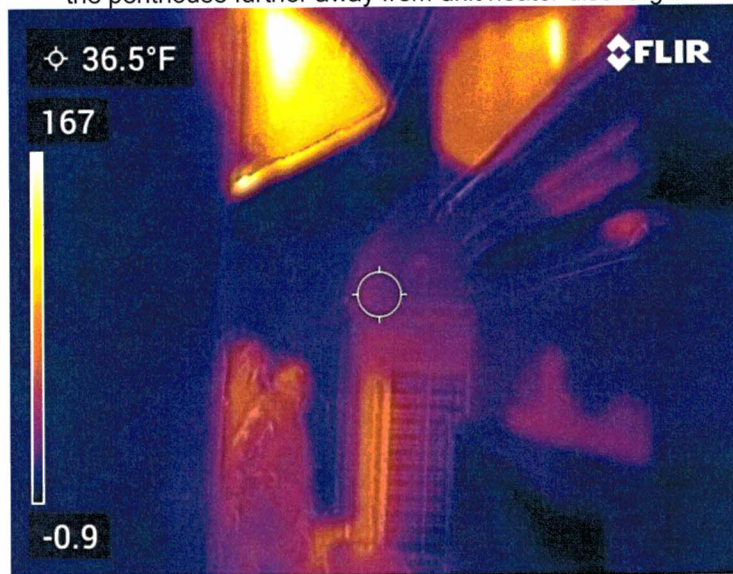
**Figure 10.** Thermal image showing discharge from unit heater directed onto VRV condenser. Note that edge of VRV condenser is warm and is much cooler farther from unit heater discharge.

The configuration of the Unit Heater pointed directly at the VRV system is not a recommended way to maintain temperature for the HVAC system for the facility. This type of configuration can lead to false load signals.

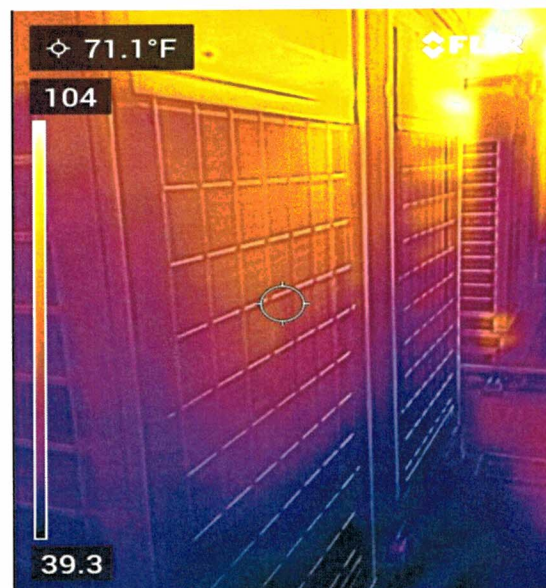
**Figure 11.** Thermal image of VRV condensers. Note warmer temperatures at top of condenser and cooler temperatures toward bottom of condensers.

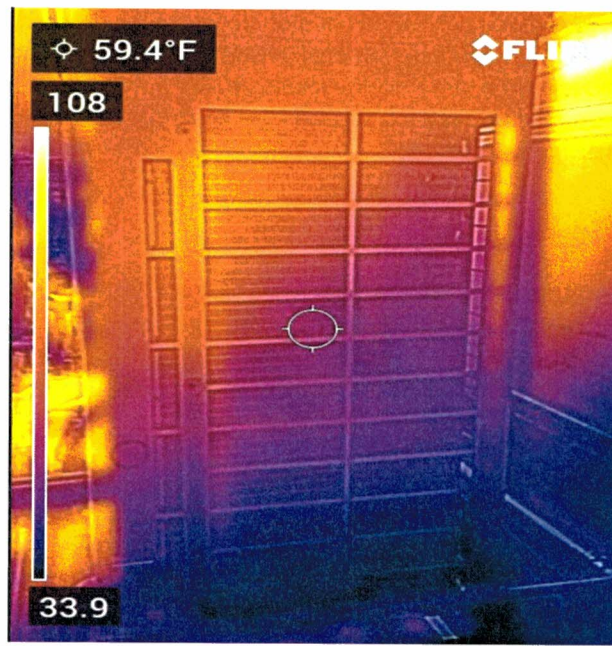
**Figure 12.** Thermal image of side of VRV condenser. Note warmer temperature on upper left of condenser and cooler to bottom right.

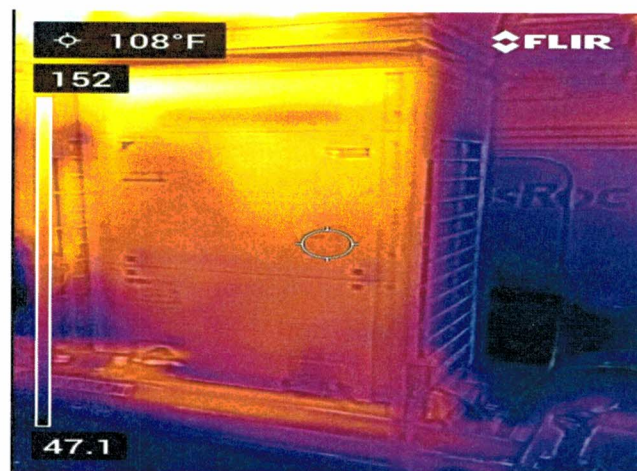
**Figure 13.** Thermal image of VRV condenser. Note warm temperature on front access panel of condenser which is directly under unit heater discharge. Temperature is much cooler on the right side of condenser where coil fins are located.

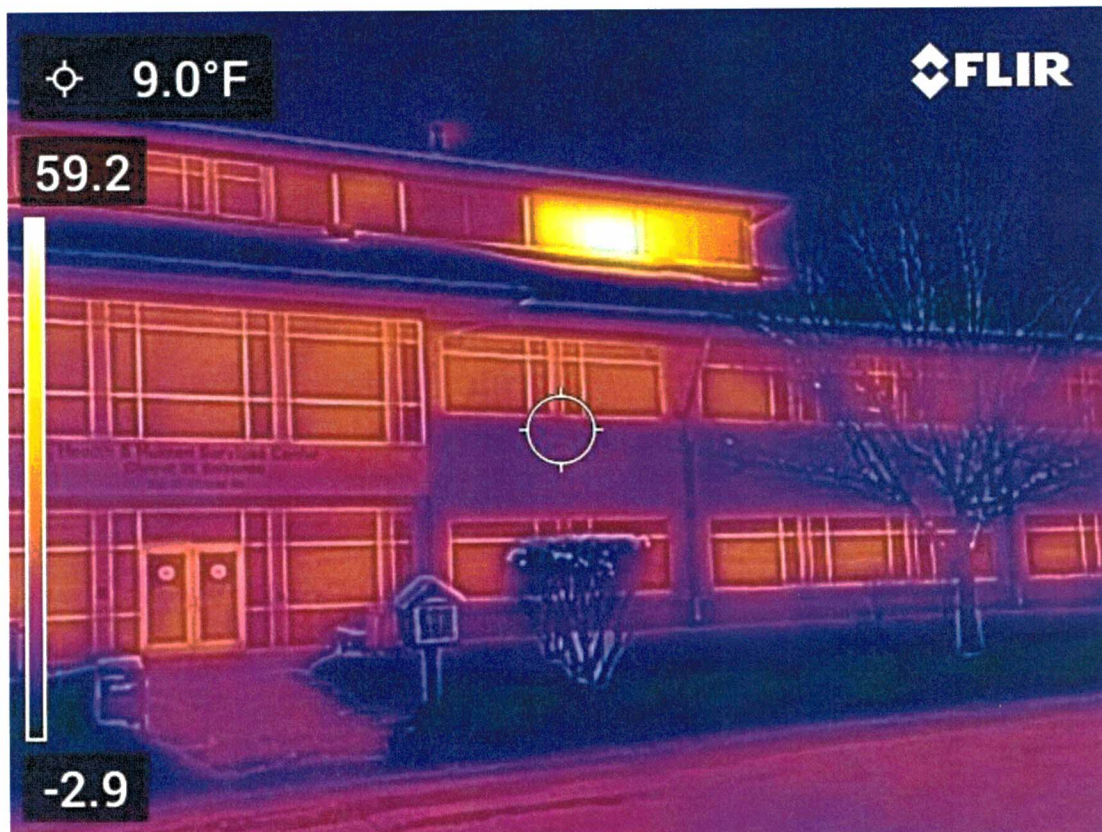
**Figure 14.** Thermal image of exterior enclosure of HHS facility (North Side- Chapel Street Entrance). Note the heat from the penthouse from the VRV Exhaust.

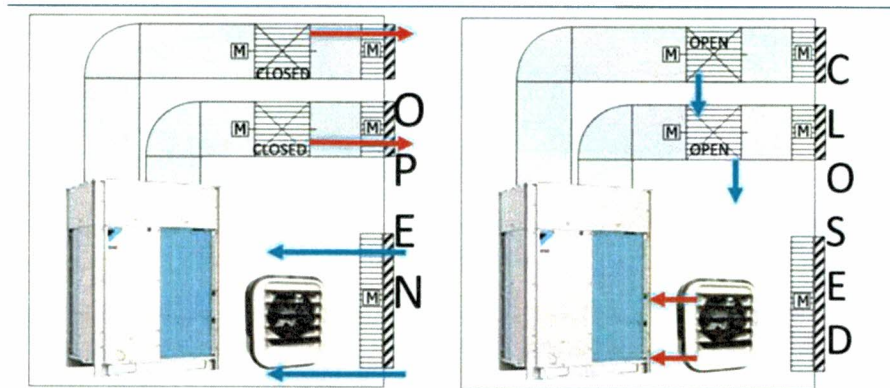
**Figure 15.** Graphic on recommended damper placement. The left graphic is for summer operation and the graphic on the right is for winter operation.

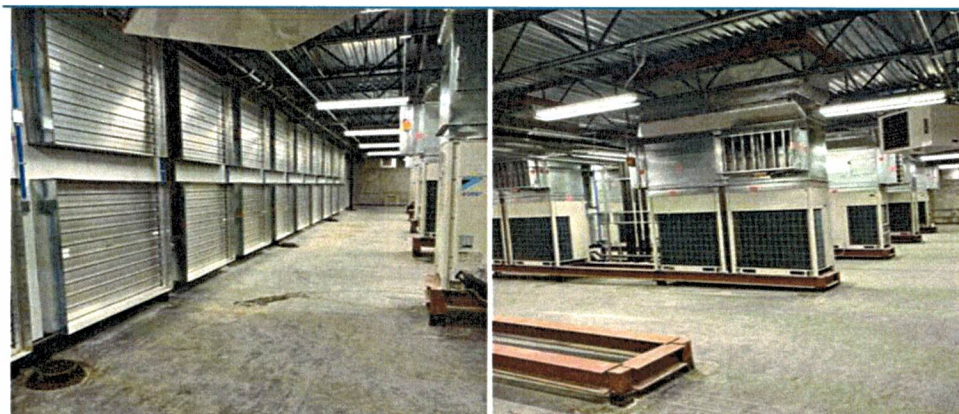
**Figure 16.** Graphic showing an actual installation of indoor condensers with closed outside air dampers and open recirculation dampers.

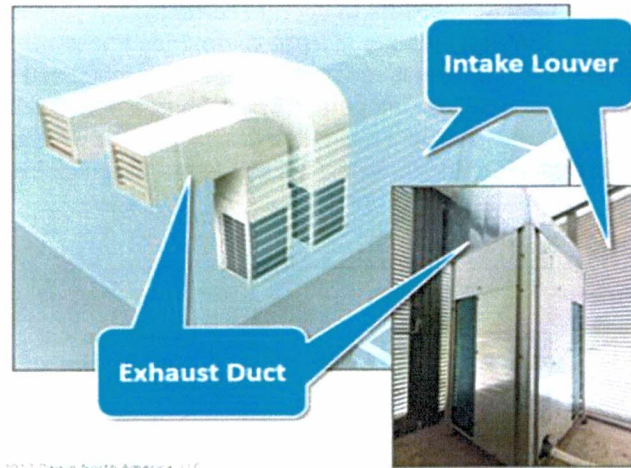
**Figure 17.** Graphic from Daikin sales representative showing recommended exhaust duct arrangement
