MEMORANDUM #1

SUBJECT: Wheatland Road Corridor Plan – Existing and Future Forecast Project #20020-009
Conditions

The primary objective of the Wheatland Road Corridor Plan project is to develop a multimodal corridor plan and conceptual street design that removes barriers for all modes of travel, considers the latest urban safety improvements for pedestrians (refuge medians, street lighting, pedestrian activated flashers), bicycles (separated multi-use paths or buffered/protected bikes lanes), and transit riders (updated facilities and waiting areas), and creates an enjoyable experience for users of all ages and abilities. The project will also include community involvement to assure the design plan is consistent with the needs of key stakeholders (including neighborhoods, schools, and businesses).

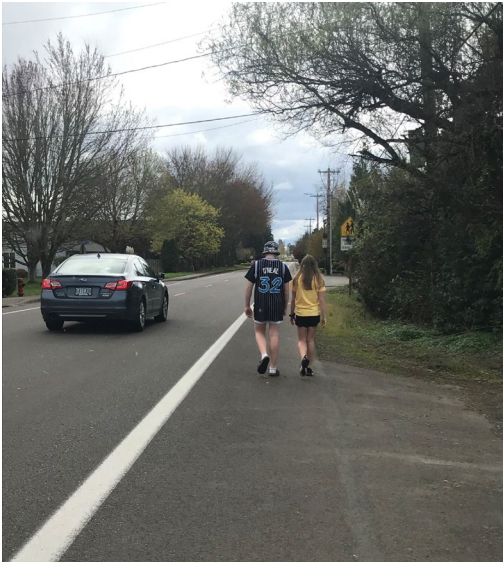
FIGURE 2: PEDESTRIANS WALKING ON ROAD SHOULDER

There are existing segments of paved sidewalk along Wheatland Road in multiple areas with many gaps. This provides poor pedestrian connectivity with numerous places without sidewalk on either side of the road. Figure 2 shows a typical example of pedestrians walking along the shoulder of the road.

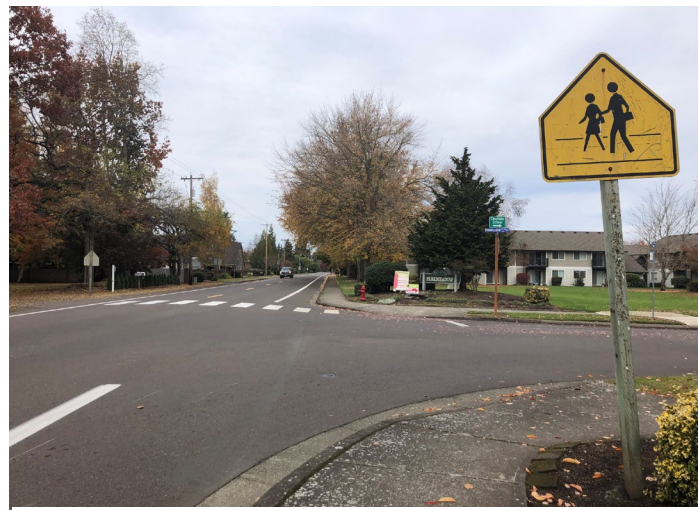
**FIGURE 7: PARKMEADOW DRIVE MARKED
SCHOOL CROSSWALK**

There are marked school crosswalks at Parkmeadow Drive (north leg, with a crossing guard) and at Clear Lake Road (south leg and east leg). While the crosswalks are marked, each intersection is missing curb ramps with the marked crosswalks. Figure 6 shows the Parkmeadow Drive marked school crosswalk.

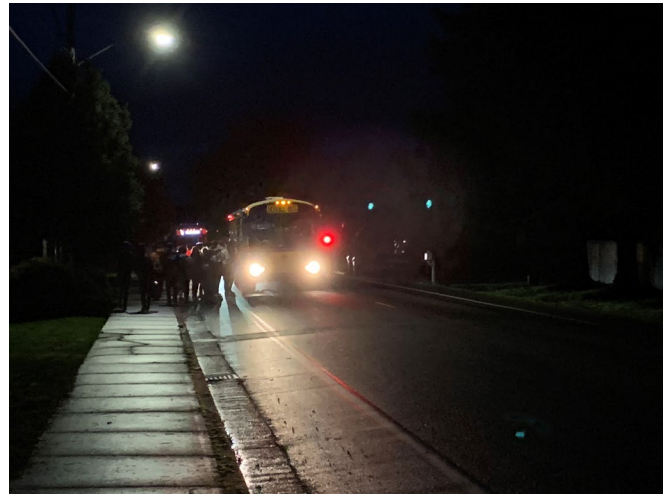
FIGURE 8: DARK CONDITIONS AT A SCHOOL BUS STOP

Street lighting observations were conducted along the Wheatland Road project area during the nighttime conditions on November 30, 2020. There is some existing street lighting along most of Wheatland Road corridor. Observed light levels indicate that additional lighting along the study corridor is needed. Existing lighting along the corridor is mainly located on utility poles and is not uniform, creating contrast between light and dark sections and making it difficult to identify pedestrians, bikes, and motor vehicles on or crossing the street. Visibility is especially challenging at several of the school bus stops as shown in Figure 9. Supplemental lighting along the corridor would be needed to meet current street lighting guidelines (average light levels and uniformity).
