Lower Elk Creek Wetland Enhancement Project

Stillwater Sciences. 2025. Lower Elk Creek Wetland Enhancement Project. Conceptual Design Alternatives Report. Prepared by Stillwater Sciences, Arcata, California for Smith River Alliance, Crescent City, California.

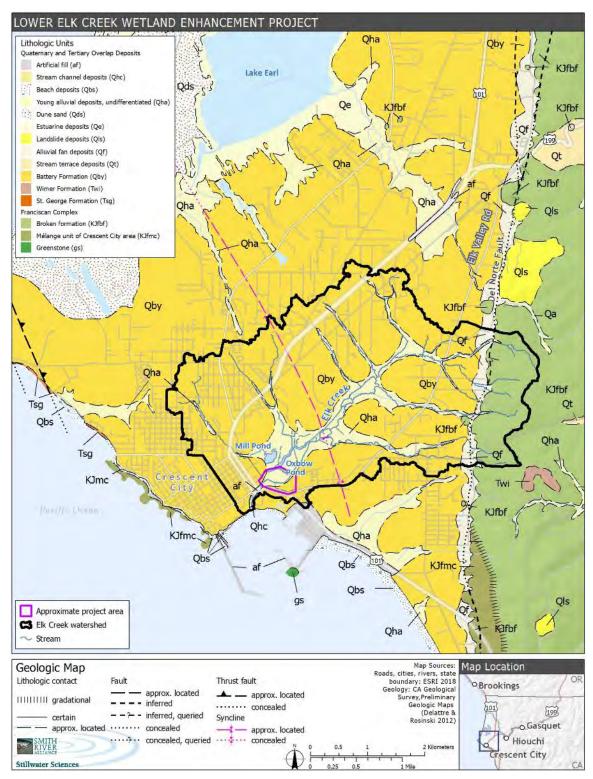
Figure 2-1. Geologic map of the Elk Creek watershed and surrounding portions of Del Norte County. The approximate Project Area is outlined in purple.

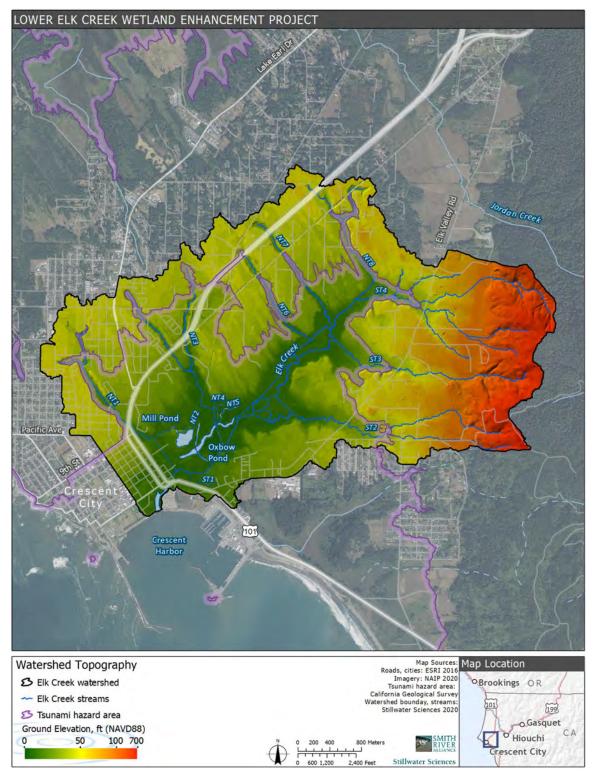
Figure 2-2. Topographic map of the Elk Creek watershed. Tsunami hazard area also shown.

NT1 drains one of the larger tributary basins on the north/northwest side of Elk Creek (Figure 2-2). The upper half of the tributary basin contains areas with a wide riparian corridor and extensive wetlands; however, the lower half of the basin has been completely altered due to urban and industrial development. NT1 used to flow across the area where the Mill Pond was constructed in the 1950s but was re-routed behind the highway commercial area into a long straight ditch with several undersized culverts that range from 350-600 feet long, each.

The upstream model extents were assigned three flow hydrograph boundary conditions to simulate the main channel and two larger tributaries (North Tributary 1 and North Tributary 3) (see Figure 2-2). The main downstream boundary condition was assigned a variable tidal stage corresponding to MLLW, MSL, MHHW, and projected SLR. Along the interface with Hwy 101 and city streets, multiple free outfall boundaries were applied to simulate runoff capture of the urban stormwater drainage system. This approach was used because flooding extents in initial model runs were greater than believed realistic, and detailed stormwater system modeling was beyond the scope of this assessment. The ground surface roughness characteristics for the models were defined in HEC-RAS with spatially discrete areas, which are a plan view of Manning's n zones and values for the model domain. Manning's values (i.e., roughness values) were assigned based on standard references (Chow 1959), field observations, and aerial imagery (Table 2-3).

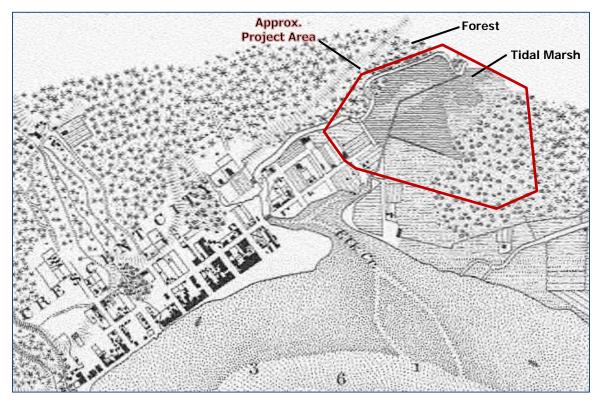
Figure 2-3. Crop from 1859 U.S. Coast Survey map. Map symbols upstream of city blocks indicate tidal marsh and mixed hardwood and conifer forest surrounding Elk Creek in the Project Area. Approximate Project Area outlined in red.

The landcover symbols in the 1859 map depict tidal marsh (i.e., closely drawn parallel horizontal lines) across the valley bottom in the Project Area, which is just upstream of the city blocks. The map also shows mixed hardwood and conifer forests likely dominated by Sitka spruce and red alder extending out from both valley margins. Such tidal forested swamps used to form the majority of coastal wetlands in the Pacific northwest, with only approximately 5% remaining today (Brophy 2019). The shoreline in Crescent Harbor extended up to the edge of the city blocks along the present-day location Front Street. Figure C-1 in Appendix C shows the shoreline and lower Elk Creek channel margins delineated with a blue line. This shoreline delineation is retained in each historical map and photograph in Appendix C to illustrate the land and stream alterations in the Elk Creek stream-estuary ecotone.

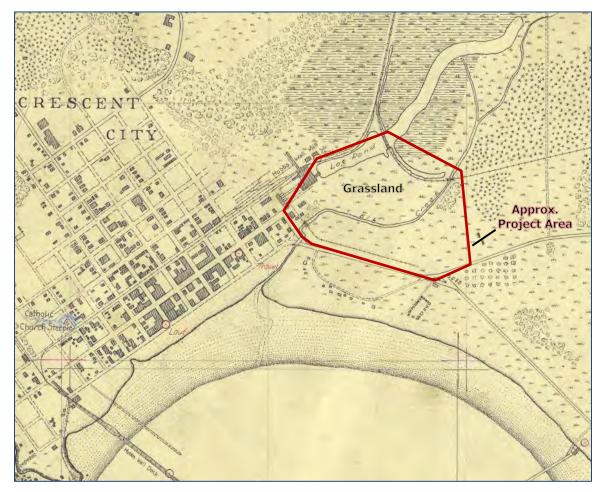
Figure 2-4. Crop from 1928 U.S. Coast and Geodetic Survey map. Map symbols upstream of city blocks indicate that tidal marshes and forests in the Project Area were converted to grasslands. Approximate Project Area outlined in red.

By 1928 the downtown development in Crescent City expanded, completely infilling the former Elk Creek channel and estuary where it flowed between city blocks (Figure 2-4). The creek was relocated into narrow excavated channels along the southeast margin of the lower valley. Throughout the Project Area the creek channel is bordered by levees built of spoils from excavating the new channel. The presumed former natural channel was substantially expanded by dredging to create the sequence of ponds referred to in this report as the Oxbow Pond but labeled as the Log Pond in Figure 2-4. The ponds were used for log storage by the Hobbs, Wall & Co. sawmill that was constructed in the late 1800s. Additional drainage ditches and cross channels were constructed in the Project Area vicinity to drain the fields for grazing pasture and to provide fill for the Del Norte and Southern Railroad grade that traversed the lower valley. Not evident in the historical maps but indicated by subsurface soil borings in the Project Area (Hemphill-Haley et al. 2019) and supported by the National Marine Fisheries Service (NMFS 2014), the wetlands in the lower Elk Creek valley had been filled and elevated by 1928 to create suitable land for livestock grazing. The landcover symbols in the 1928 map depict grasslands across the Project Area where there used to be a tidal marsh and spruce forest, indicating widespread wetland filling and logging to support urban, agricultural, and industrial development. The shoreline was also filled and extended up to approximately 100 feet seaward along some portions of Crescent Harbor.

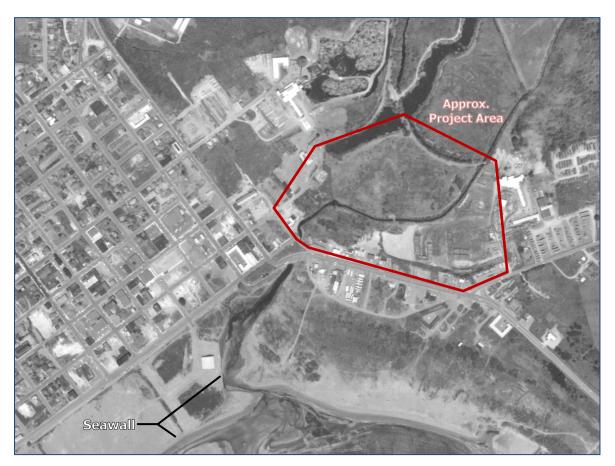
Figure 2-5. Crop from 1965 aerial photograph. Seawalls constricted the estuary downstream of the highway while sawmilling expanded north of the Project Area.

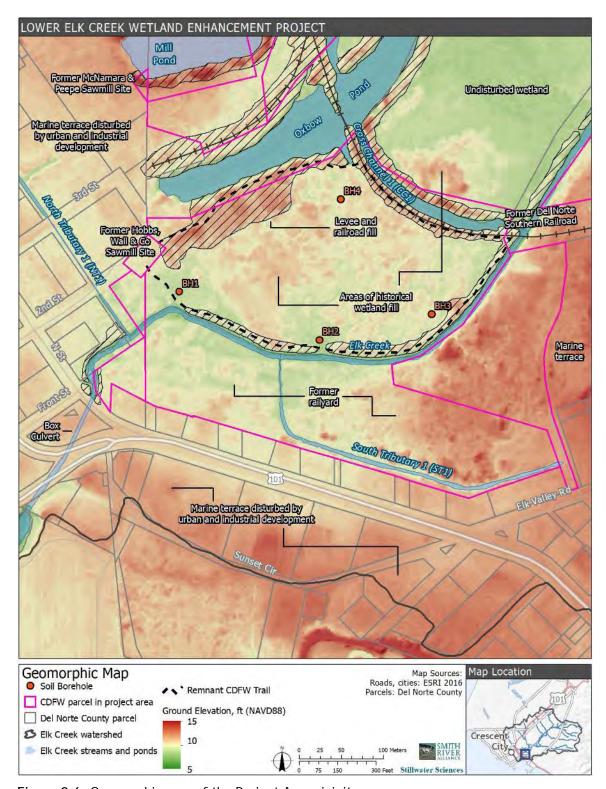
Figure 2-6. Geomorphic map of the Project Area vicinity.

Additional reaches of Elk Creek upstream and downstream of the Project Area were evaluated during the geomorphic characterization to assess for reference conditions. The Project Area is primarily within the CDFW Wildlife Area, although the County owns portions of the creek channel and former railroad alignment in the northeast corner of the Project Area, and private parcels border the downstream end of Elk Creek and the Oxbow Pond (see Figure 1-2 and Figure 2-6).

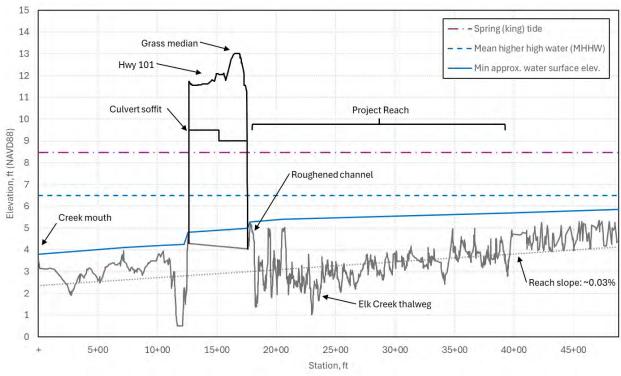
Figure 2-7. Longitudinal profile of Elk Creek in the Project Area vicinity.

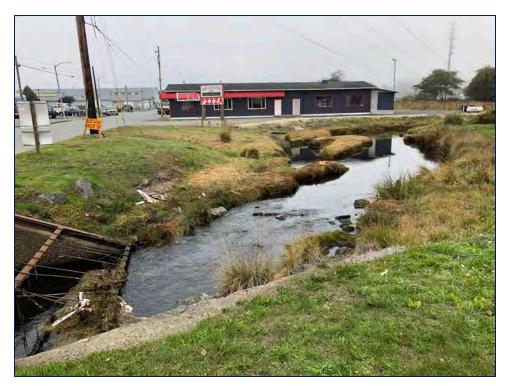
Figure 2-8. Elk Creek upstream of Hwy 101 crossing. Culvert inlet headwalls and trash rack in bottom left. Roughened channel in center. View looking upstream.

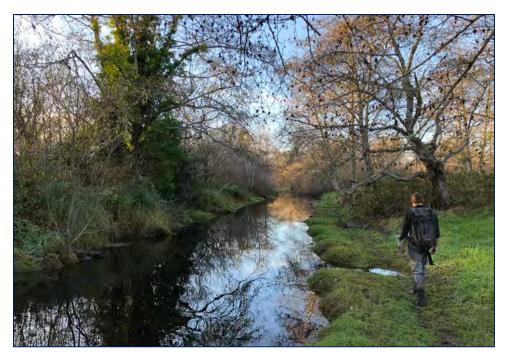
Figure 2-9. Elk Creek between NT1 and ST1. View looking downstream.

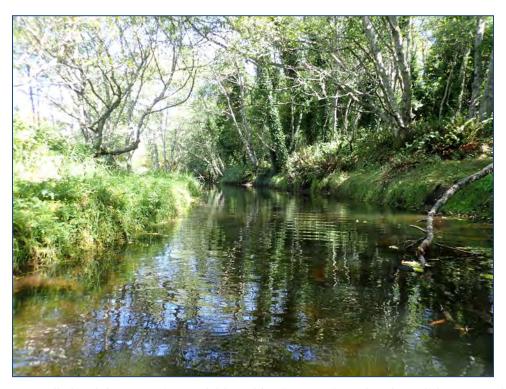
Figure 2-10. Elk Creek between ST1 and CC1. Alder forest infested with English ivy at right. View looking upstream.

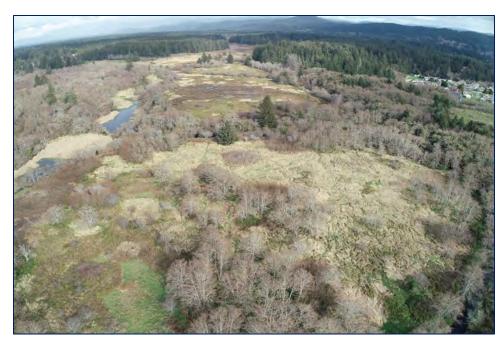
Figure 2-11. Aerial view of CDFW Wildlife Area (foreground) in winter. Dry RCG stalks are light beige color. Elk Creek at lower right corner, Oxbow Pond at left, CC1 obscured by trees in center. View looking upvalley.

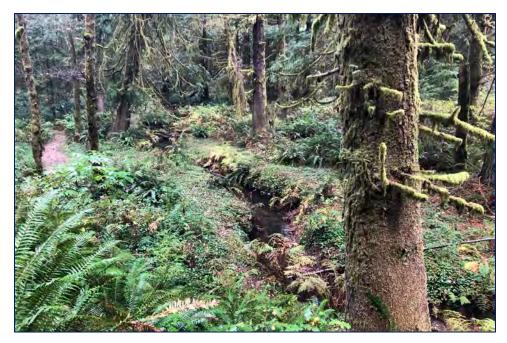
Figure 2-12. Reference site on Elk Creek upstream of the Project Area. Elk Creek at center, view looking downstream.

The geomorphic assessment included evaluating conditions in reference sites to inform the Project designs. Due to the long history of landscape alterations and habitat conversions in the Project Area vicinity (see Section 2.3), there are no undisturbed reference sites in lower Elk Creek. Farther up the valley there are some areas with no evidence of disturbance based on historical aerial photograph analysis. Sites were evaluated that are located on the flat valley bottom and along the margin of slight uplands, similar to the upstream portion of the Project Area. The reference areas are upstream of tidal influence unfortunately, and therefore do not provide an example of tidal channel forms or brackish vegetation, but instead are indicative of mixed coastal riparian forest that previously was present in the Project Area (Figure 2-12). The forest is dominated by Sitka spruce with some deciduous hardwood trees and woody shrubs, and a dense herbaceous understory with ferns and skunk cabbage. Beaver are present and downed trees create pool habitat and hydraulic diversity in the creek channel.

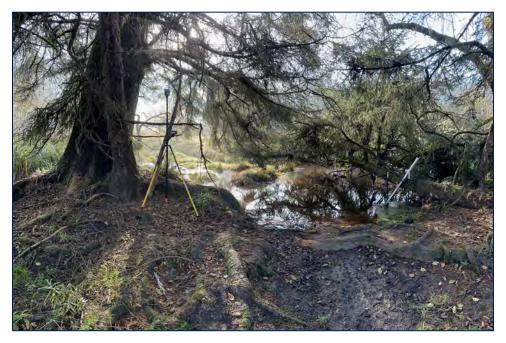
Figure 2-13. Reference site at Spruce Creek in the Smith River estuary. RCG visible in unshaded areas in background. 2-meter survey rod for scale.

Additional reference sites were evaluated at Spruce Creek in the Smith River estuary. Lower Spruce Creek is a tidal swamp. The ground surface is hummocky with depressions created from upturned rootwads of downed trees. In some cases, downed trees act as nurse logs for new trees and support roots that splay out horizontally to avoid inundation from the creek (Figure 2-13). The channel is sinuous and multi-threaded in areas where it meanders around hummocks or into depressions created by upturned rootwads. Spruce Creek also has areas infested with although deeper brackish water and shade from trees are effective at limiting its distribution. Beaver are present in Spruce Creek and the area visible in Figure 2-13 is just upstream of a dam.

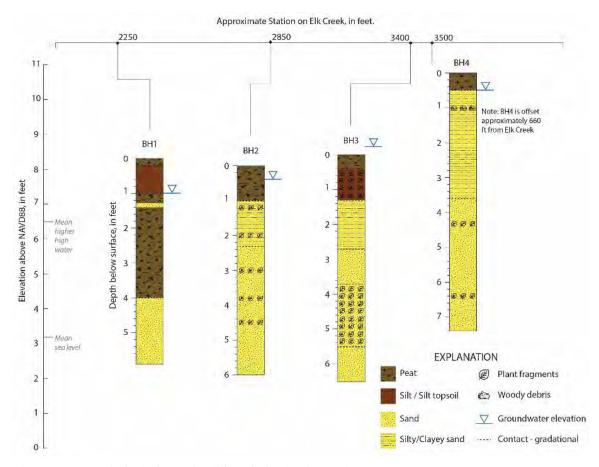
Figure 2-14. Lithologic logs of soil boreholes in the Project Area.

Borehole 4 is located in the wetlands north of the creek near the Oxbow Pond and is approximately 660 feet from Elk Creek. The stratigraphy consists of (from top to bottom) approximately 0.5 feet of peat that contains RCG plant fragments and rhizomes in a muddy matrix with silt. Below the peat is silty sand/sandy silt that is muddy, with loose consistency and some redoximorphic mottling. The unit contains some wood fragments and fine roots and extends to approximately 3.6 feet bgs. From 3.6 feet to the bottom of the hole at 7.4 feet is clean fine sand that is loose and dark gray. The sand contains occasional fine plant fragments. Static groundwater was observed at 0.5 feet bgs.

The peat in borehole 1 (BH1) from approximately 1 to 4 feet below ground surface is anomalous and is possibly a fill deposit of fine wood shavings from the former Hobbs, Wall & Co sawmill. The thin sand layer, or lens, at 1.3 feet below ground surface in BH1 may be a tsunami deposit, possibly from 1964. If it is a 1964 tsunami deposit, then the overlying organic silt and peat would also be fills potentially emplaced when the sawmill was decommissioned.

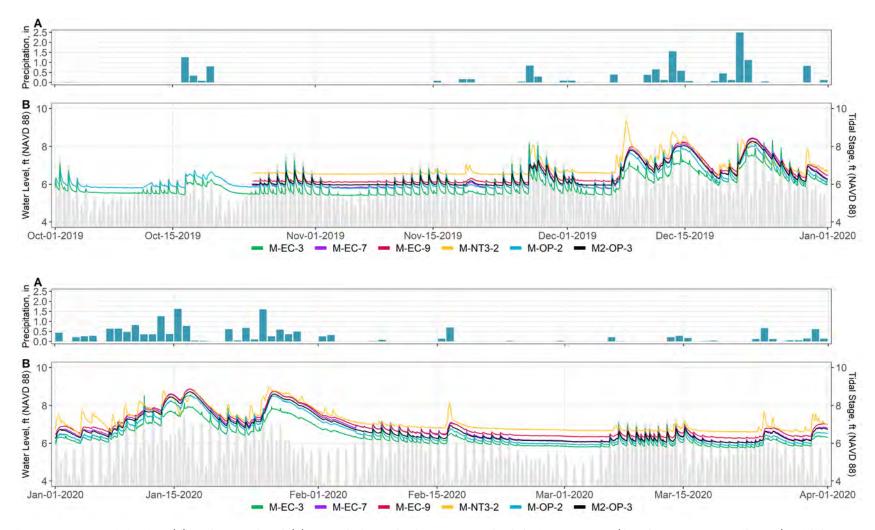
Figure 2-15. Precipitation (A) and water level (B) records from the lower watershed during WY 2020 (October 2019 to April 2020). Tidal stage from Crescent City (Station ID# 9419750) depicted by gray curve. M-EC-2 is in Elk Creek at the North Tributary 1 confluence and M-OP-2 is in the Oxbow Pond at the Cross Channel 1 confluence. The other data series are farther upvalley.

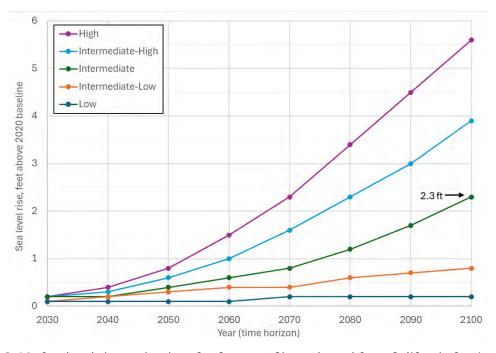
Figure 2-16. Sea level rise projections for Crescent City, adapted from California Sea Level Rise Guidance (2024). This Project incorporates projections at the 2100 time horizon (2.3 feet rise) on the Intermediate sea level scenario.

For each sea level scenario, the 2024 guidance provides amounts of relative sea level rise (in feet) by decade from 2020 to 2150 for various locations across California, including Crescent City (Figure 2-14). The projections incorporate local estimates of vertical land motion determined from nearby global positioning system (GPS) stations. The vertical land motion estimates do not include the possibility of large earthquakes due to the uncertainty in predicting when such events will occur (J. Kimball, pers. comm., 2024). Hydraulic modeling was used to analyze the projected sea level rise amount for Crescent City at the 2100 time horizon (2.3 feet).

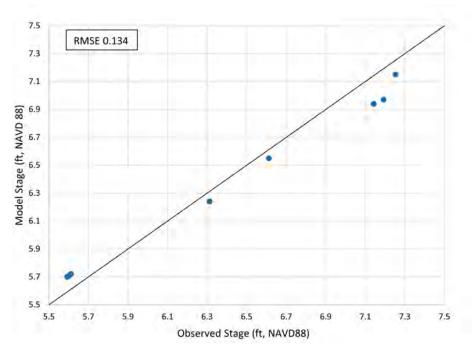
Figure 2-17. Comparison of observed and modeled water stages used for model calibration.

The model was evaluated against eight observed stage-discharge points, spanning flows from approximately 7 cfs to 79 cfs. The root mean square error (RMSE) between modeled and

observed stages was 0.134 feet, indicating good agreement. Most modeled stages were within ± 0.2 feet of observed values, with only two points exceeding this threshold. Residuals tended to slightly underpredict stage at higher flows, but the model remained within a reasonable error range across the calibration domain.

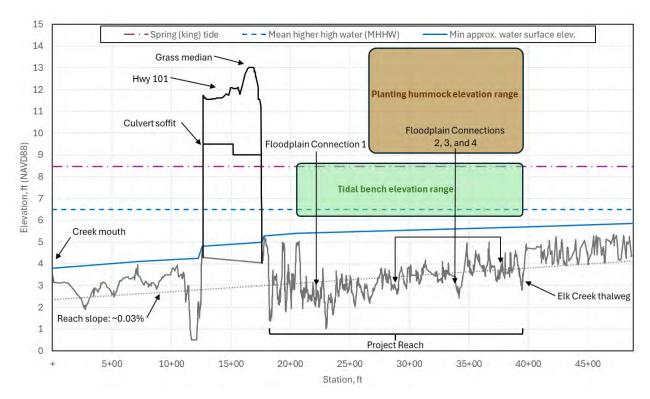
Figure 3-1. Longitudinal profile of Elk Creek and key proposed design features.

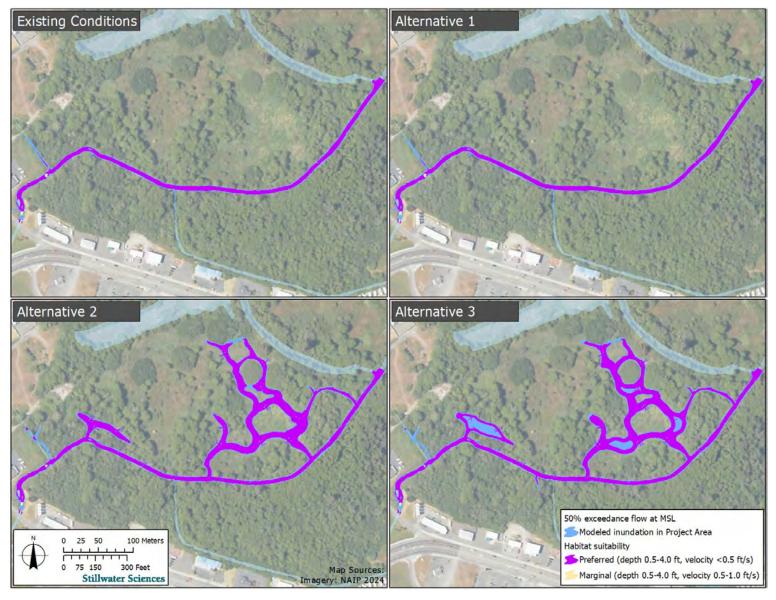
Figure 3-2. Modeled habitat suitability for design alternatives in the Project Area for the 50% exceedance flow at mean sea level.

Preliminary hydraulic modeling was conducted to evaluate suitable fish habitat under existing conditions and for each design alternative. Habitat was evaluated at the 10% and 50% exceedance flows with mean sea level (MSL) tidal conditions. During a typical year the 10% exceedance flow

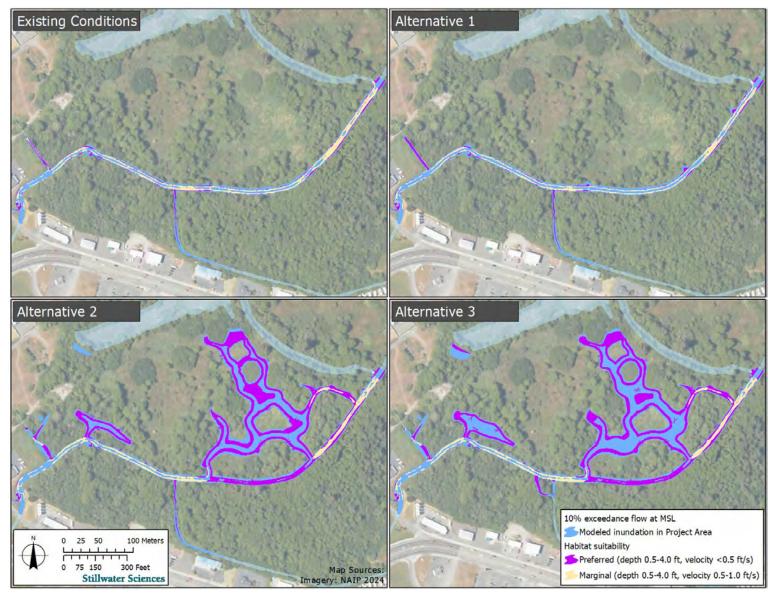
Figure 3-3. Modeled habitat suitability for design alternatives in the Project Area for the 10% exceedance flow at mean sea level.

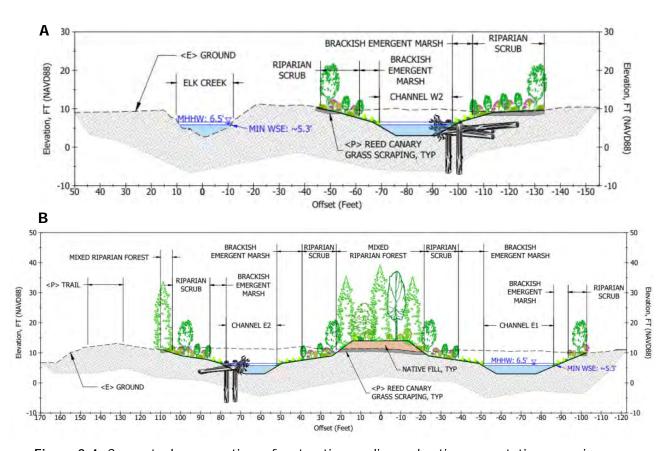
Figure 3-4. Conceptual cross sections of restoration grading and native revegetation zones in the (A) west grading and (B) east grading areas of design Alternative 2. See Conceptual Design Plans in Appendix A for additional cross sections.

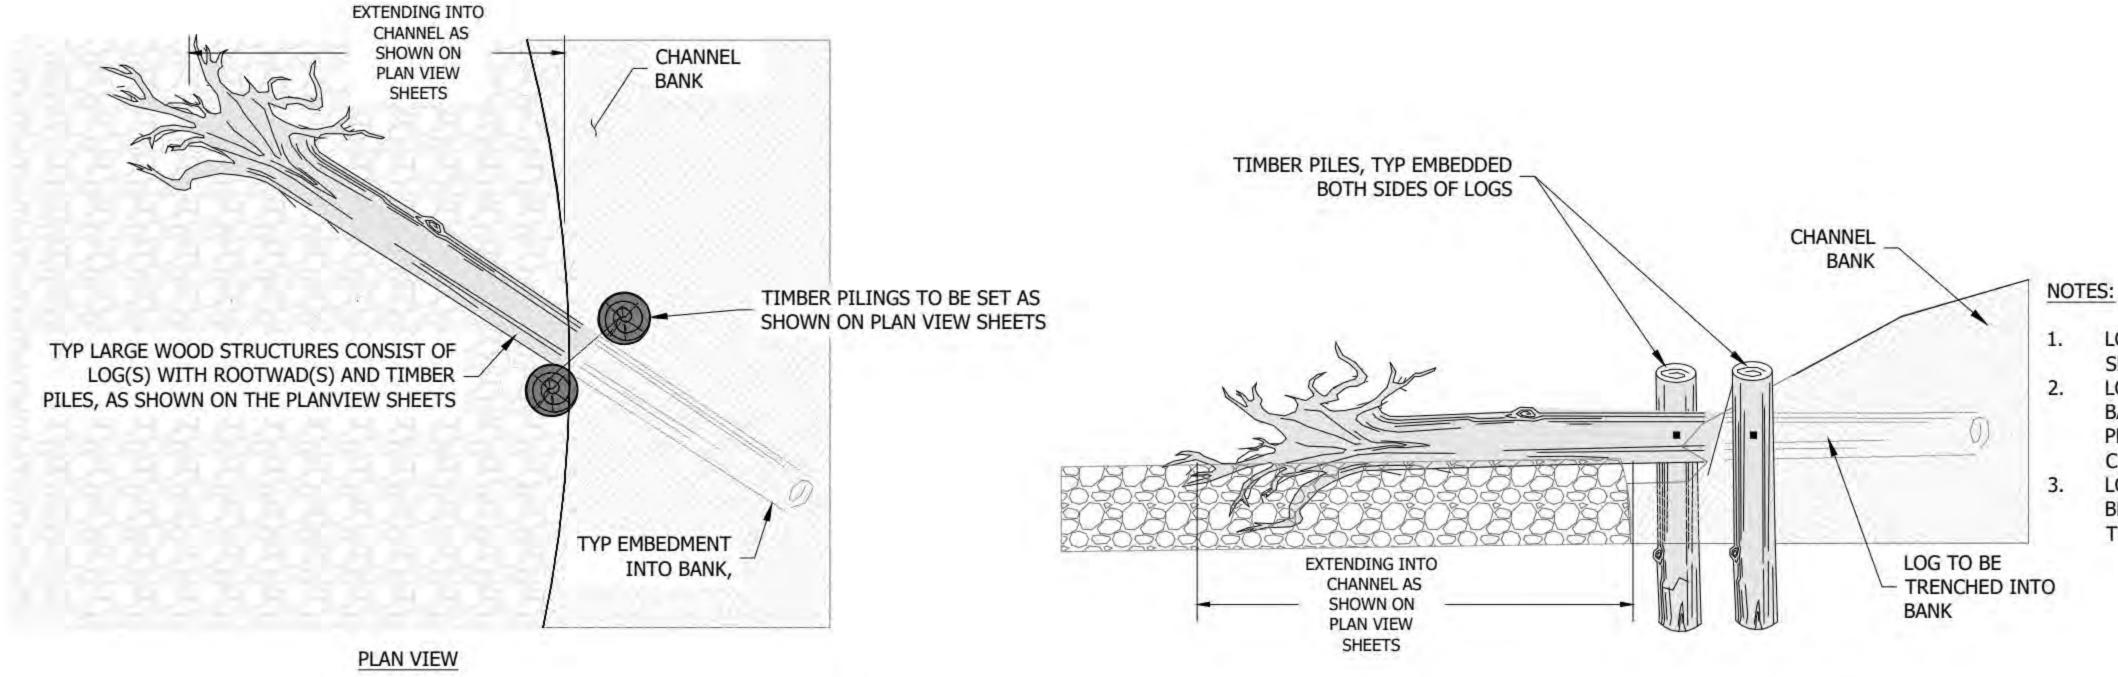
- LOG STRUCTURES SHALL BE INSTALLED AS SHOWN ON PLAN VIEW SHEETS
- LOG STRUCTURES TO BE TRENCHED INTO THE BANK TO ALLOW FOR A LOWER ANGLE AND PROVIDE MORE WOOD VOLUME IN THE ACTIVE CHANNEL
- LOG STRUCTURE CONSTRUCTION DETAILS MAY BE MODIFIED IN THE FIELD AS APPROVED BY THE PROJECT MANAGER AND ENGINEER

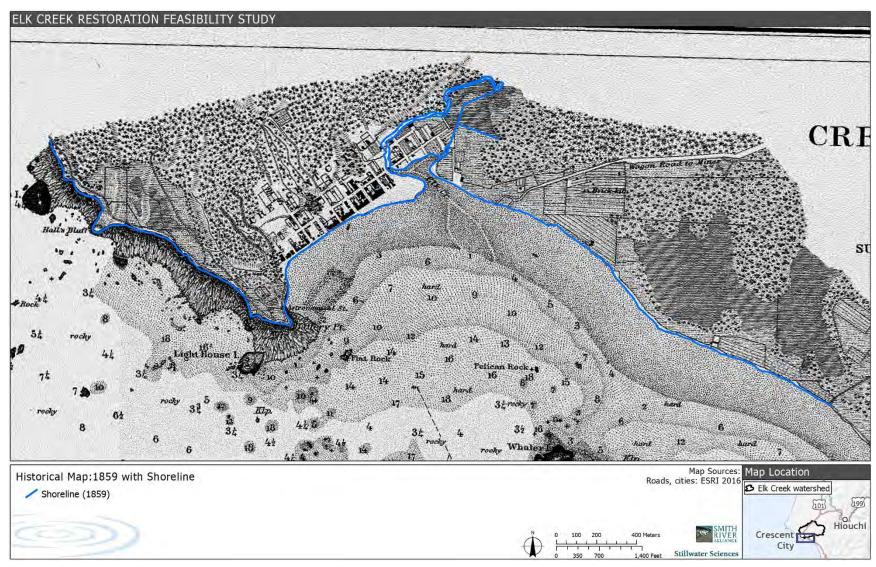
Figure C-1. U.S. Coastal Survey map of 1859 with shoreline and lower Elk Creek delineated.

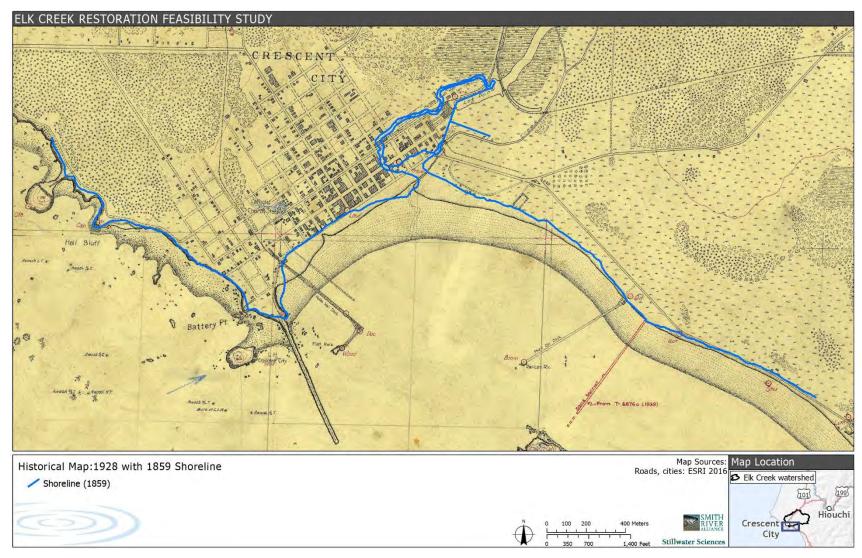
Figure C-2. U.S. Coastal Survey map of 1928 with 1859 shoreline and lower Elk Creek delineated.

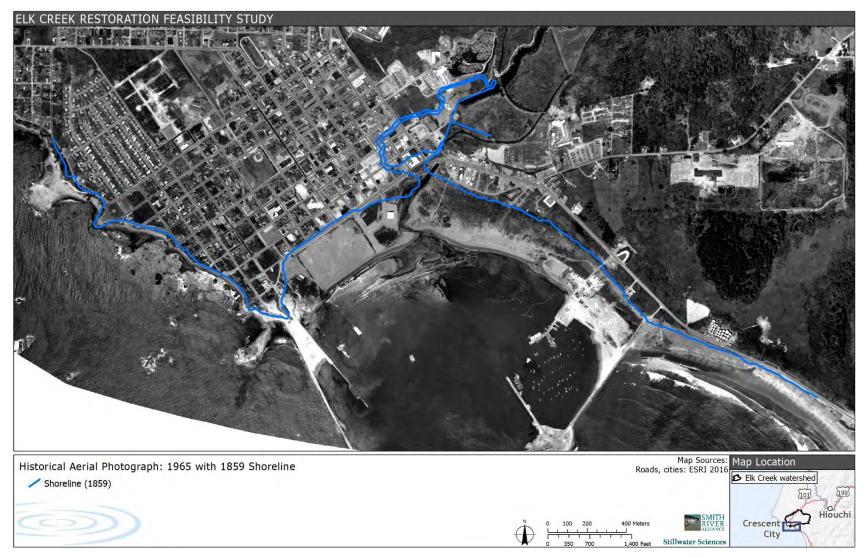
Figure C-3. Aerial photograph from 1965 with 1859 shoreline and lower Elk Creek delineated.

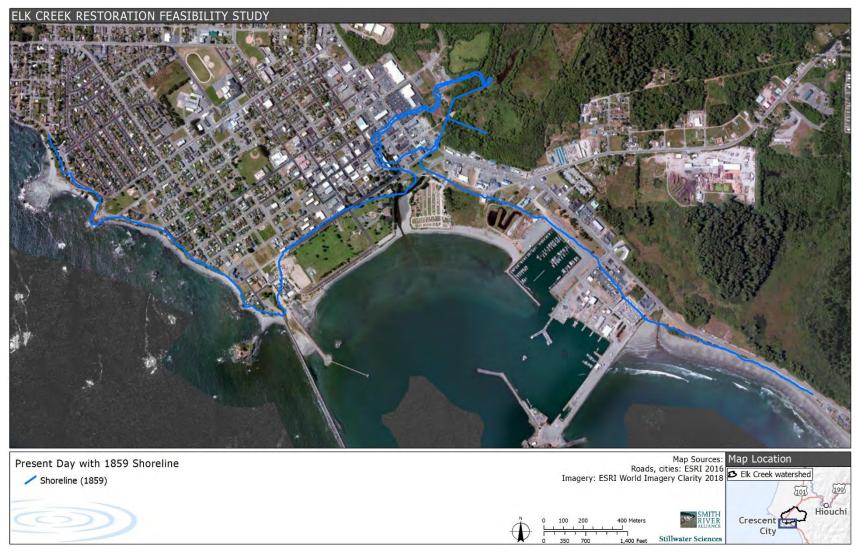
Figure C-4. Aerial photograph from 2018 with 1859 shoreline and lower Elk Creek delineated.
