City of Derby WPCA
Engineering Services
Monthly Engineering Report
November 19, 2025

2150155 Route 34 Sewer: CT DOT Project

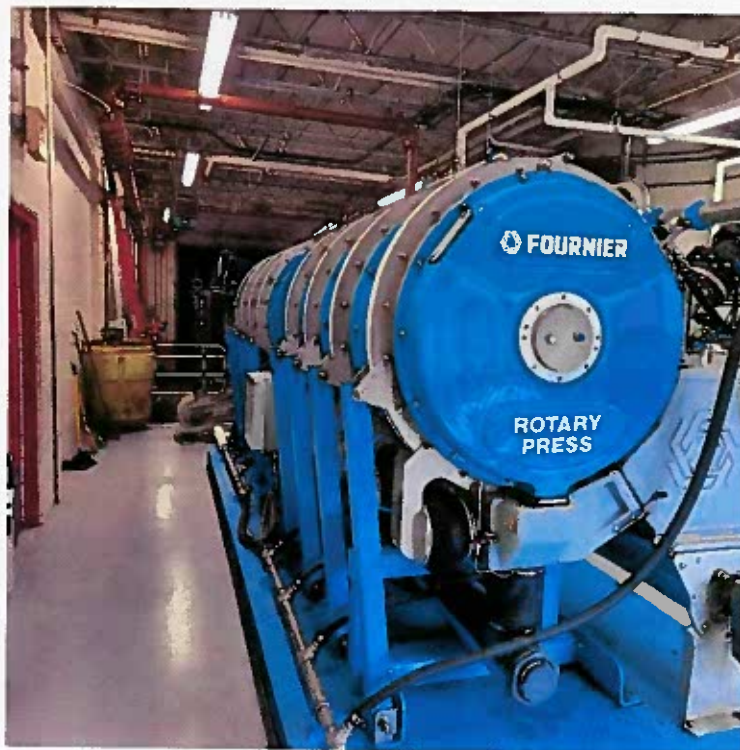
Primary Building Press Room - Solid Waste Press Machine

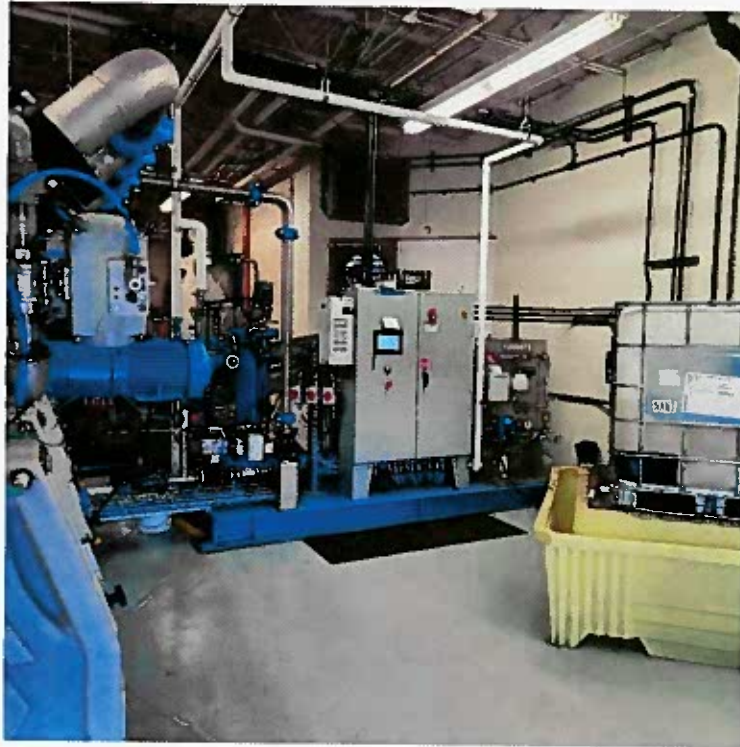
- Water leak around conveyer wall penetration observed causing puddling on floor around press
 - Obvious visible suspect mold growth not observed
 - No fresh air intake on gas furnace used for heat in the area

- Rainwater was entering the press room at the conveyor belt wall penetration and puddling on the floor at the press machine.
- The Primary Building Basement Plumbing Storage Room had a small leak in the overhead cast iron waste pipe.

Pump Room Workspace with rainwater puddling on the floor from conveyor wall penetration.

- The hot air furnace used in the press room/garage space needs to have a return air filter installed and replaced as part of PM activities.
- Rainwater entering the press room at the conveyor belt wall penetration and puddling on the floor at the press machine should be addressed.

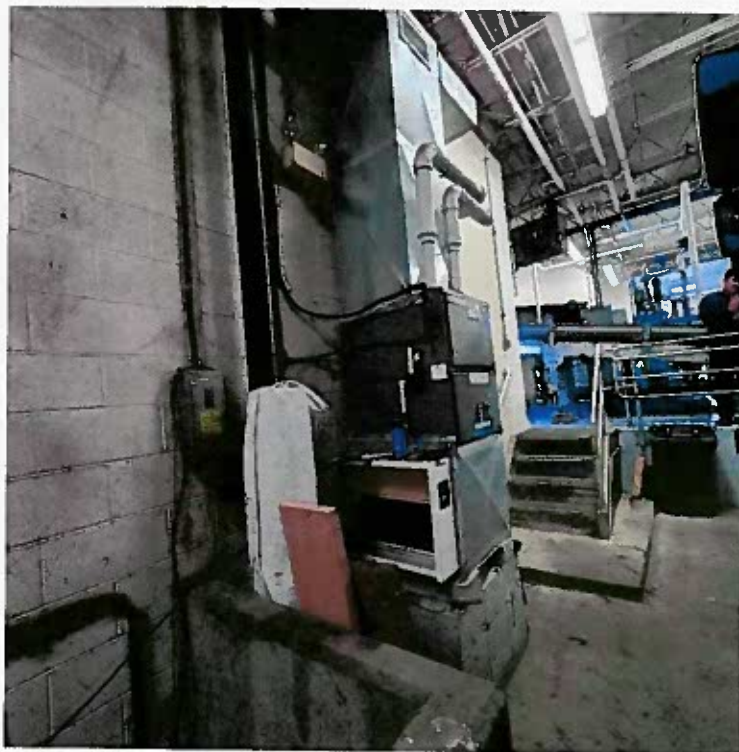
- The hot air furnace used in the press room/garage space does not take in outside air and was not observed to have a filter in place at the return air filter housing on the bottom of the unit.

Primary Building Garage Furnace with no air filter in return air filter housing

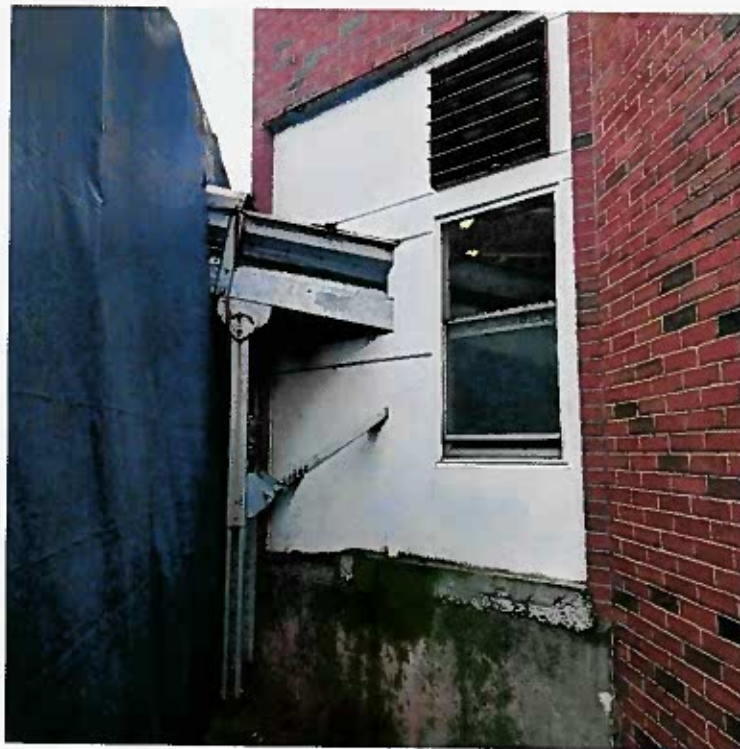
Solid Waste Conveyor Penetration where water is entering pump room and puddling in the floor

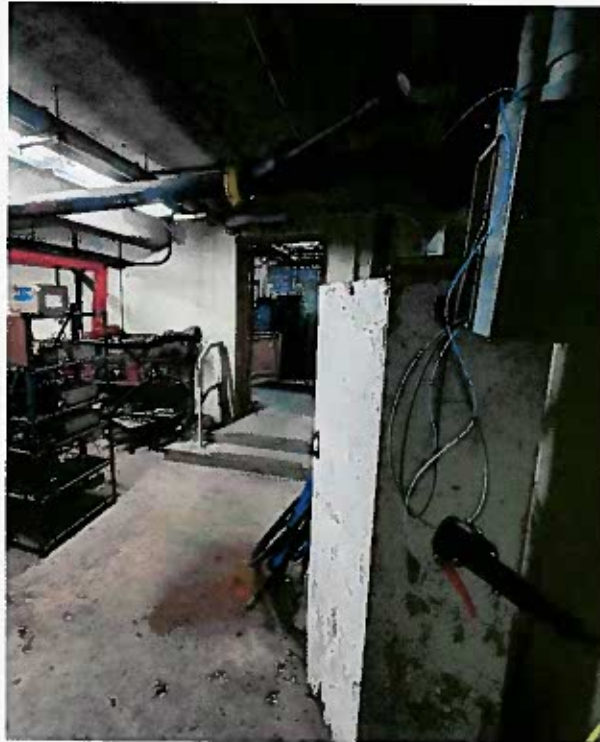
Primary building basement plumbing storage room - waste pipe leak and puddle below.

- The Primary Building Basement Plumbing Storage Room leak in the overhead cast iron waste pipe needs repair to stop leak puddling on the floor.
- Secondary Building Decommissioned Drum Thickener tank remains half full of a musty smelling liquid that should be identified/characterized, removed, and properly disposed of.

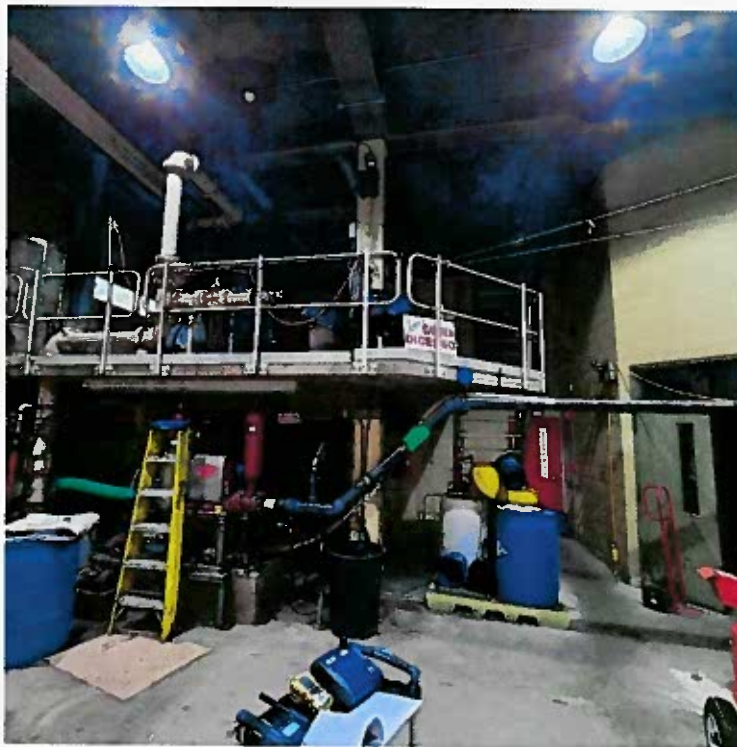
The secondary building is a two-story structure with a full basement. The main level contains decommissioned drum filter machinery, grounds maintenance equipment, electrical switch gear and used oil/parts storage space. The second floor has a laboratory space/office and a generator loft. The laboratory office space is cooled by wall mounted heat and air conditioning mini split units, while the main level is heated by a suspended gas unit heater. The basement contains process pumps on one side and three air blowers on the other side. Make-up air for the blowers comes through a floor grate from a wall louver on the main level. Former air-handling equipment/ducts remain in place and are no longer used. Interior finishes are primarily concrete block and gypsum wallboard. The exterior is brick with a flat roof.

Secondary Building Main Level Decommissioned drum thickener/filter machinery

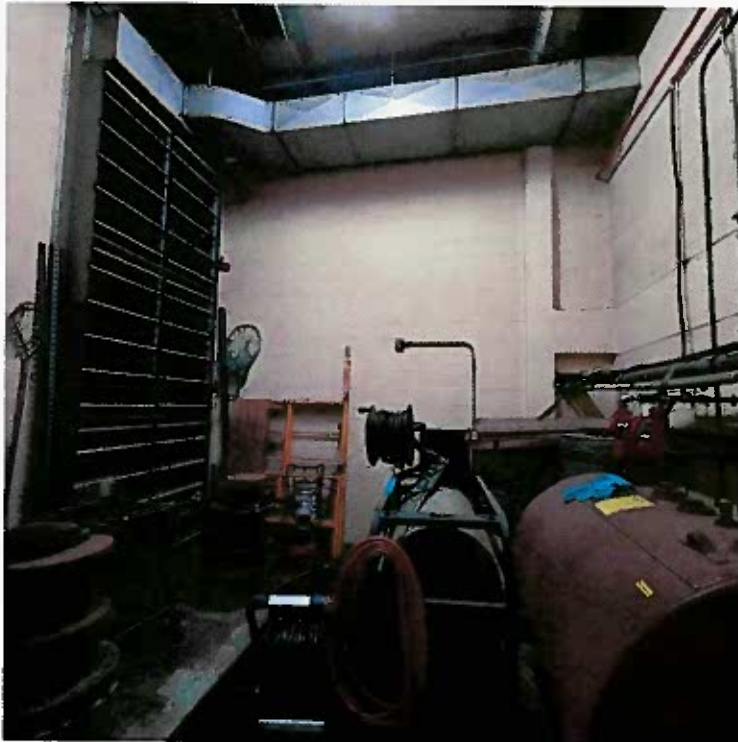
Secondary Building Main Level Air Intake Louvers and Floor Grate (Blower Make-up Air) & Generator Fuel Tank

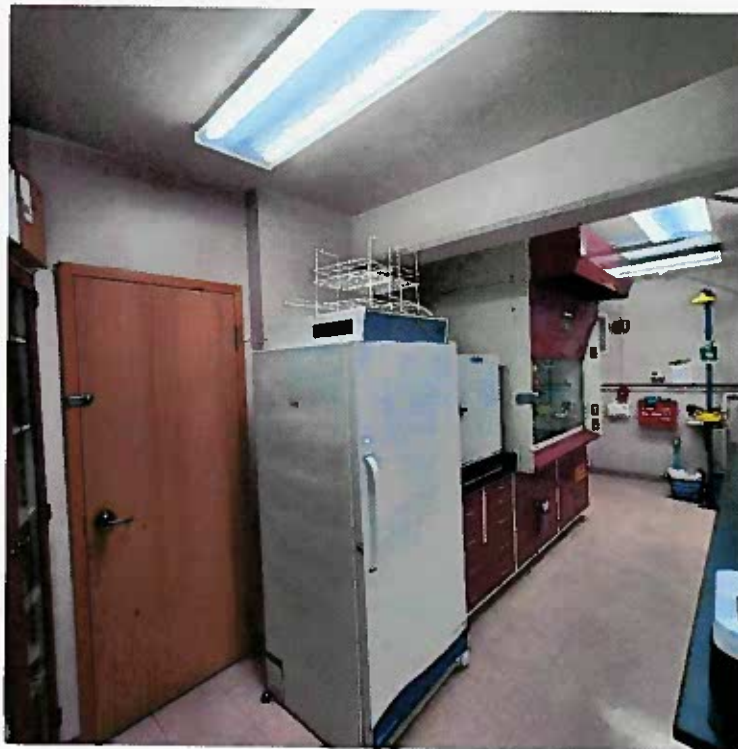
- No fresh air intake observed other than awning windows
 - Lab hood was off upon arrival with a slight odor of organics present in the lab
 - Basement houses pump equipment and air blowers

Secondary Building Upper-Level Lab - Fume Hood/Oven

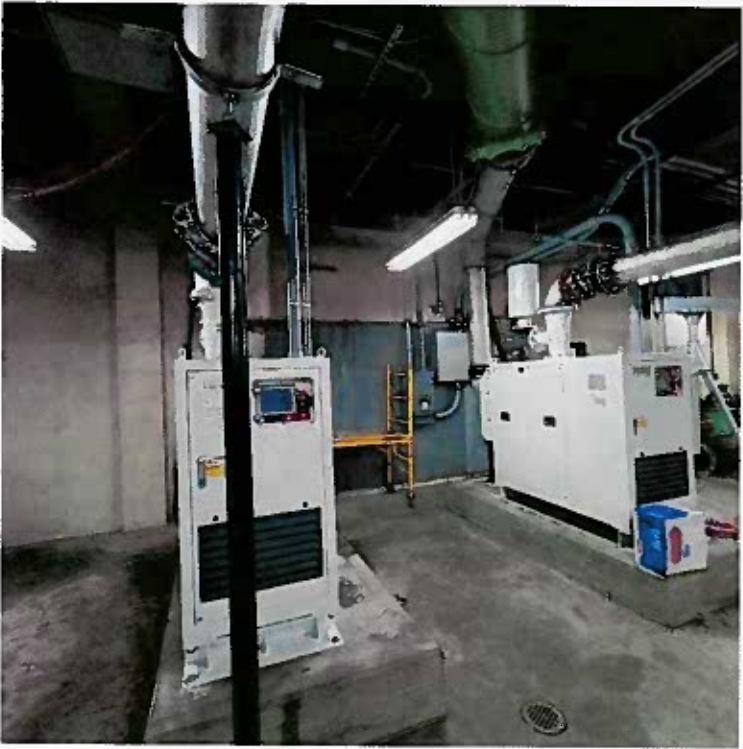
Secondary Building Basement Air Blowers

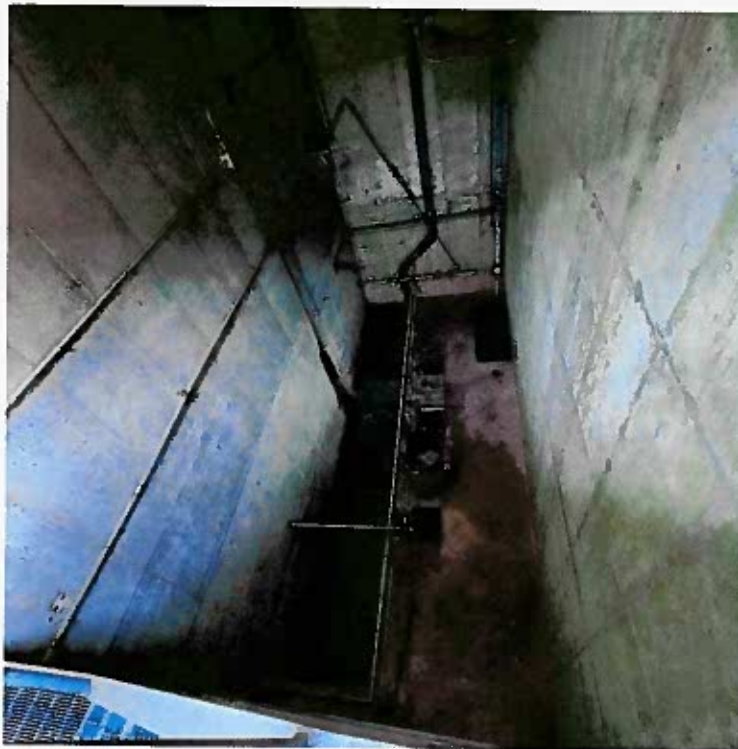
- Consists of a main level masonry equipment building with exterior subgrade concrete raw sewage inlet/strainer room
- Equipment room heated by a gas hot air unit heater
- Equipment room appeared dry with no odors observed.
- Obvious visible suspect mold growth not observed
- Raw sewer strainer pit is a concrete open top ventilated access pit/stairwell
- Occasional access to raw sewer pit space for grate strainer cleaning operations with overhead hoist to haul out strainer waste

Raw Sewage Inlet/Screens

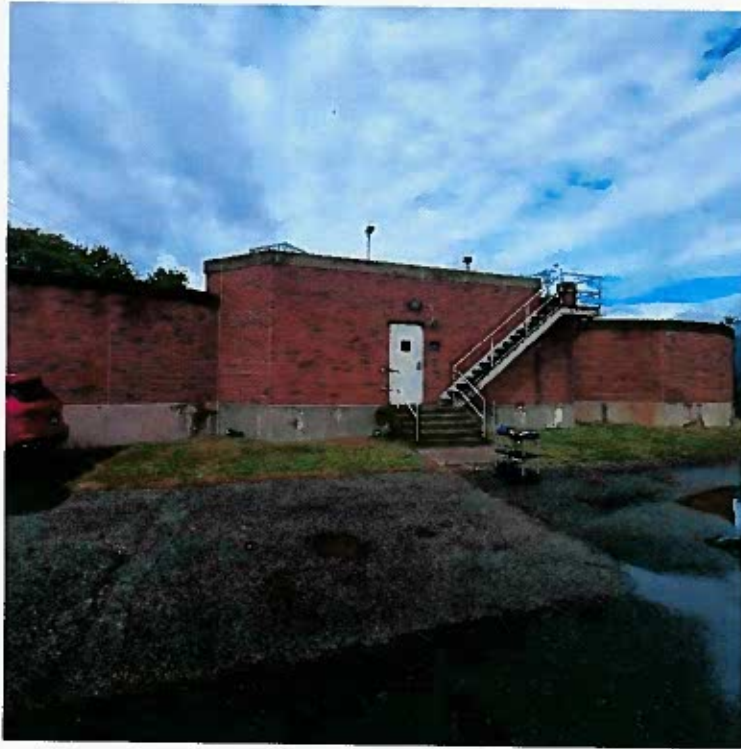
- Decommissioned equipment room with a cylindrical open top well on each side of masonry construction
- Equipment room upper level currently used for storage
- Equipment room lower-level is a former pump room
- Building appeared dry but with a musty odor, and peeling paint from inside the masonry structure at the time of the assessment
- Building was closed and dark, with no apparent ventilation, natural lighting or operating lights.
- Obvious visible suspect mold growth not observed
- Occasional access to access/store infrequently used items.

- The decommissioned Digester Building is currently used for storage on the upper level only, with occasional access by staff to store or retrieve items in the building. The space is an above and below level concrete building with no windows, no apparent ventilation and no lights at the time of the assessment. No water intrusion was evident, but the space was musty smelling. Painted masonry surfaces were peeling, which is an indicator of high moisture/humidity within the space.

Digester Building/Side Tanks
