Iowa County- Health and Human Services Building

# Iowa County- Health and Human Services Facility

## Facility Condition Review

DRAFT Report January 16, 2023

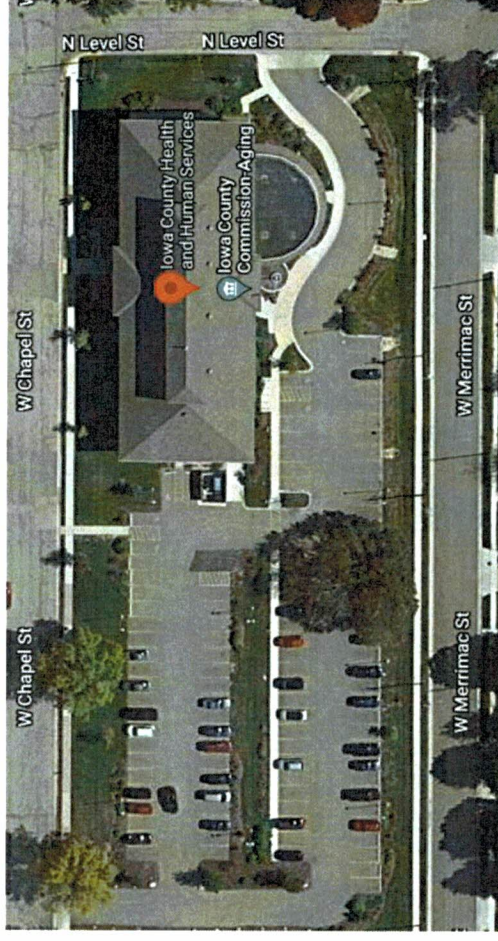
- Visited the site on December 21<sup>st</sup>, 2022
- Outside Ambient Temperature at the time of the visit was 3 Degrees F
- Reviewed the VRV configuration, the penthouse configuration and the exterior enclosure
- Temperatures in the facility ranged from 59 degrees F to 75 degrees F
- Set point for HVAC system was 72-75 F

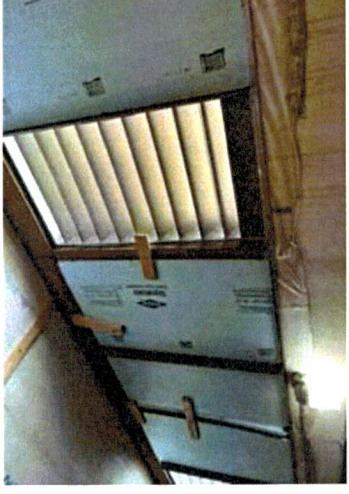
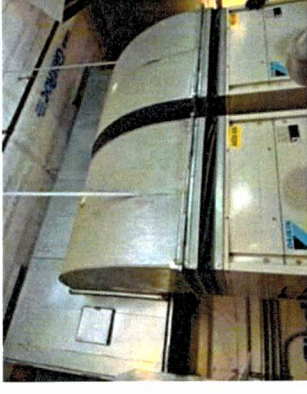
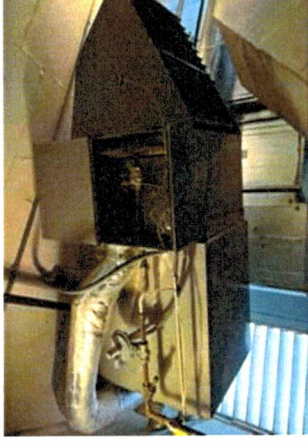
- Open louvered penthouse- no mechanical dampers
- Staff has blocked off louvers with insulated panels to try to maintain temperature
- VRV's reside in penthouse- ducted exhaust from VRV's to outside
- Large gas-fired unit heaters placed in ceiling
  - Two (2) unit heaters directed at VRV's
  - Other unit heaters are more separated from VRV's

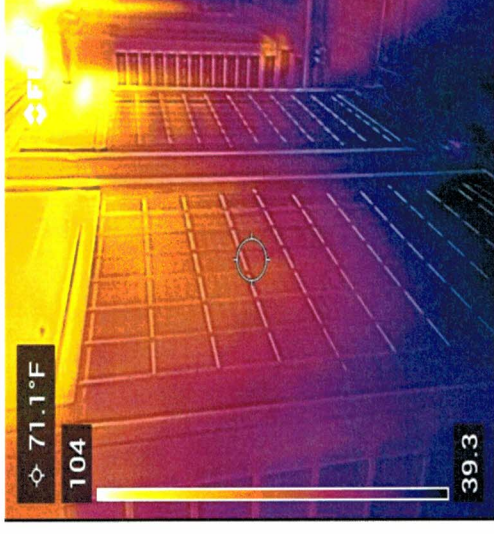
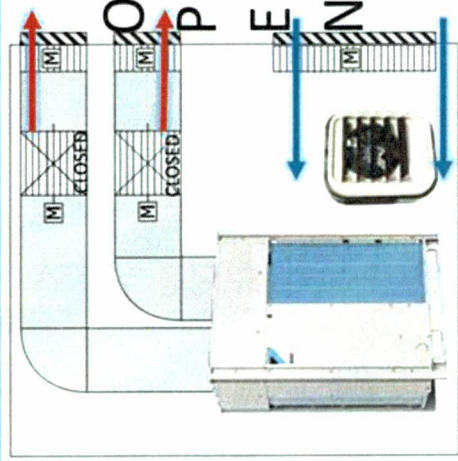
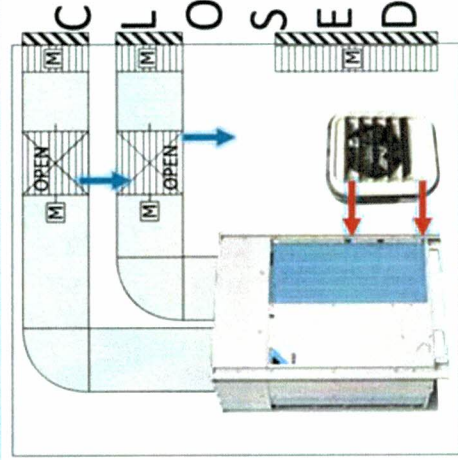
- Image is of VRV system, unit heater and duct work in penthouse
- Temperature scale: -0.9 degrees F to 167 Degrees F
- Unit heater directed at VRV, blowing hot air onto unit
- Temperature across the coil was measured
  - Range from 11 degrees F to 91 degrees F
- This range across the coil is not recommended
- Not conducive to good operational control

- Improve exhaust ductwork configuration
- Install motorized dampers to control outside air
- Discharge of unit heaters should not be directly onto VRV
  - *False load*
  - *Compressor failure*
