**A RESOLUTION OF THE TOWNSHIP COUNCIL OF THE TOWNSHIP OF  
VERONA DESIGNATING AND DECLARING THAT CERTAIN PROPERTY  
LOCATED AT 420 BLOOMFIELD AVENUE AND IDENTIFIED AS BLOCK  
701, LOT 3 BE DECLARED A NON-CONDEMNATION AREA IN NEED OF  
REDEVELOPMENT**

**Township of  
Verona  
420 Bloomfield  
Avenue  
Area in Need of  
Redevelopment  
Preliminary Investigation  
Report**

Date: January 2, 2026

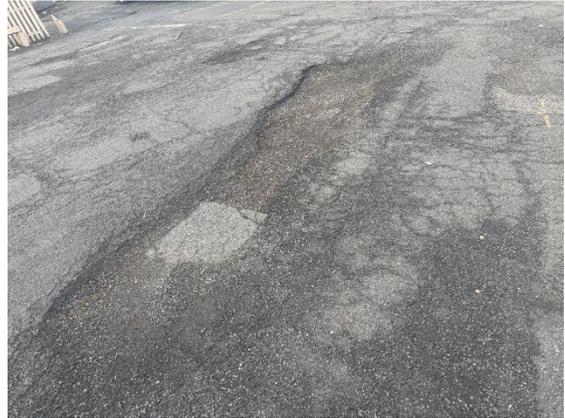
As seen in the above pictures, the parking lot is ill maintained with potholes and lack of defined parking spaces.

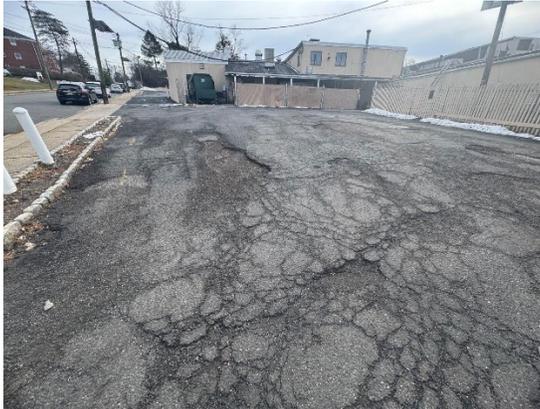
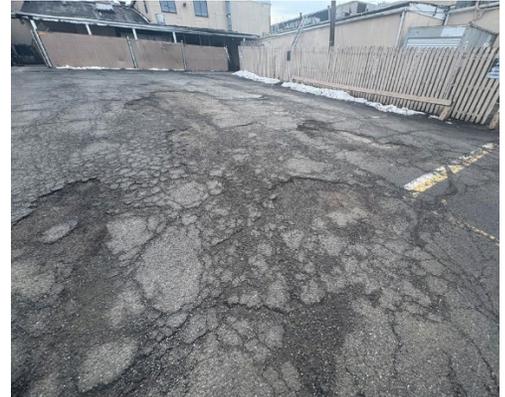
*Above Left and Right: Another view of the parking lot in the northwesterly section of the property. No clear signage for parking or loading areas is visible. The parking lot is in a state of disrepair.*

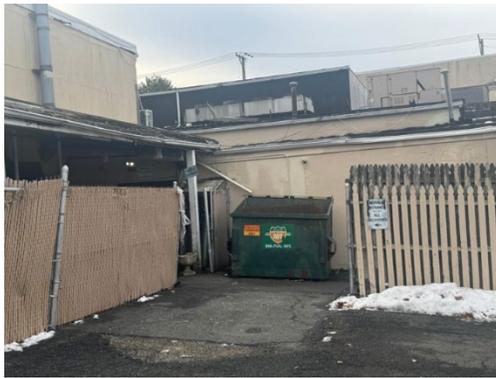
*Above Left: View of the unenclosed roofed patio with fencing. Trash receptacles are in the open without screening.*

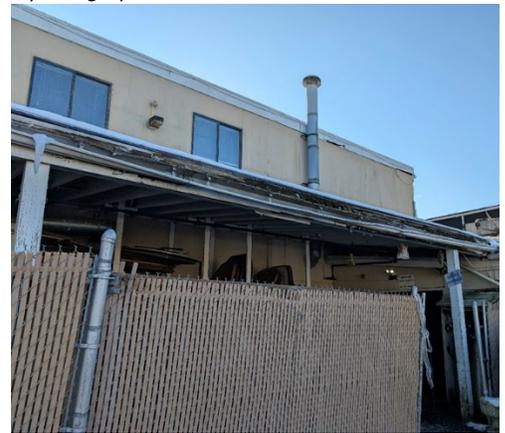
*Above Right: Close up view of the unenclosed roof and the storage area underneath it. The service entrance/walkway and storage are screened by a chain-link fence with privacy slats. The roof exhibits signs of disrepair.*

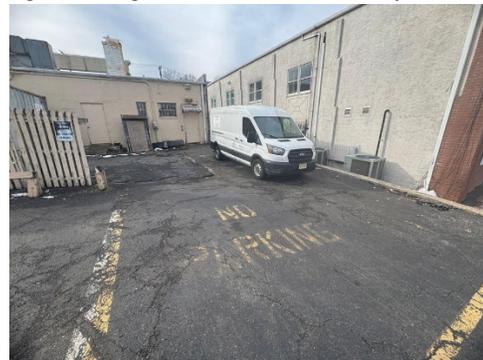
*Above Right: Another close-up view of the loading area and service entrances in northwesterly section of parking lot. The catering van is parked in the no parking area.*

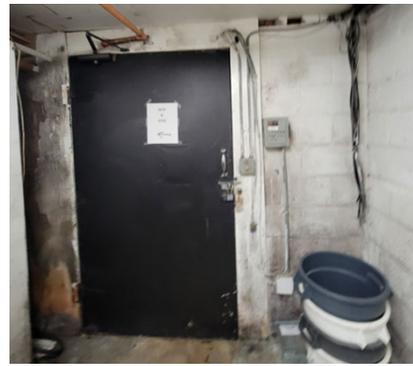
Pictured above (left) is a functional built-in refrigerator used for beverage storage in the basement. Located within the same hallway, there is another built-in refrigerator that was previously used to store beverages but is no longer functional (right).

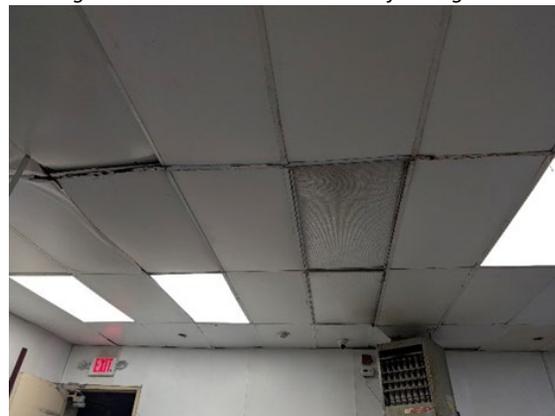
*A close-up view of the water damaged, warped ceiling tiles in the kitchen.*
