STERLING OPERA HOUSE
COMPREHENSIVE STUDY

PROGRESS UPDATE

FEBRUARY 9, 2026

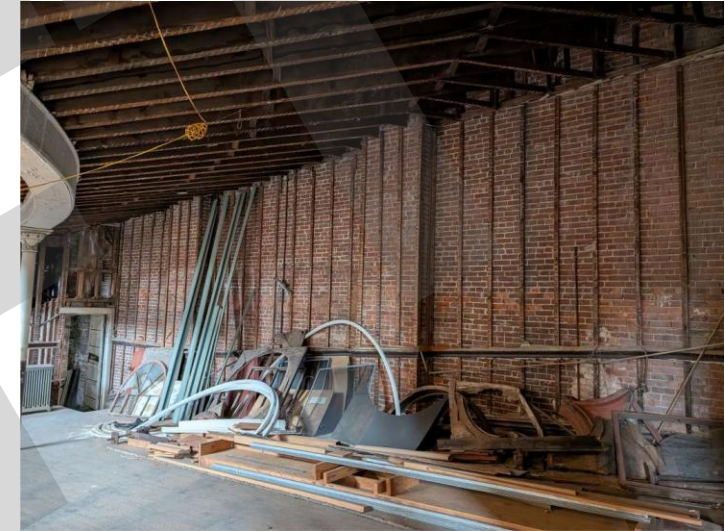
Fig. 1

- The existing conditions of the Sterling Opera House do not reflect its acoustics at its finest moments in the past, nor do they indicate the potential for its use in the future.
- The interior wall finishes are stripped in most locations (Fig. 1) and there are no operable HVAC systems contributing to its background noise conditions. To a large extent, it is a "blank slate" acoustically.
- The basic form of the facility as an intimate proscenium theater (Fig. 2) with a relatively small stagehouse offers an excellent opportunity to develop and utilize the room as a venue hosting natural acoustic performances, amplified performances, or some combination of the two.
- Historically, the theater has a reputation for its excellent natural acoustics, which is not surprising given its intimate volume and good sightlines.

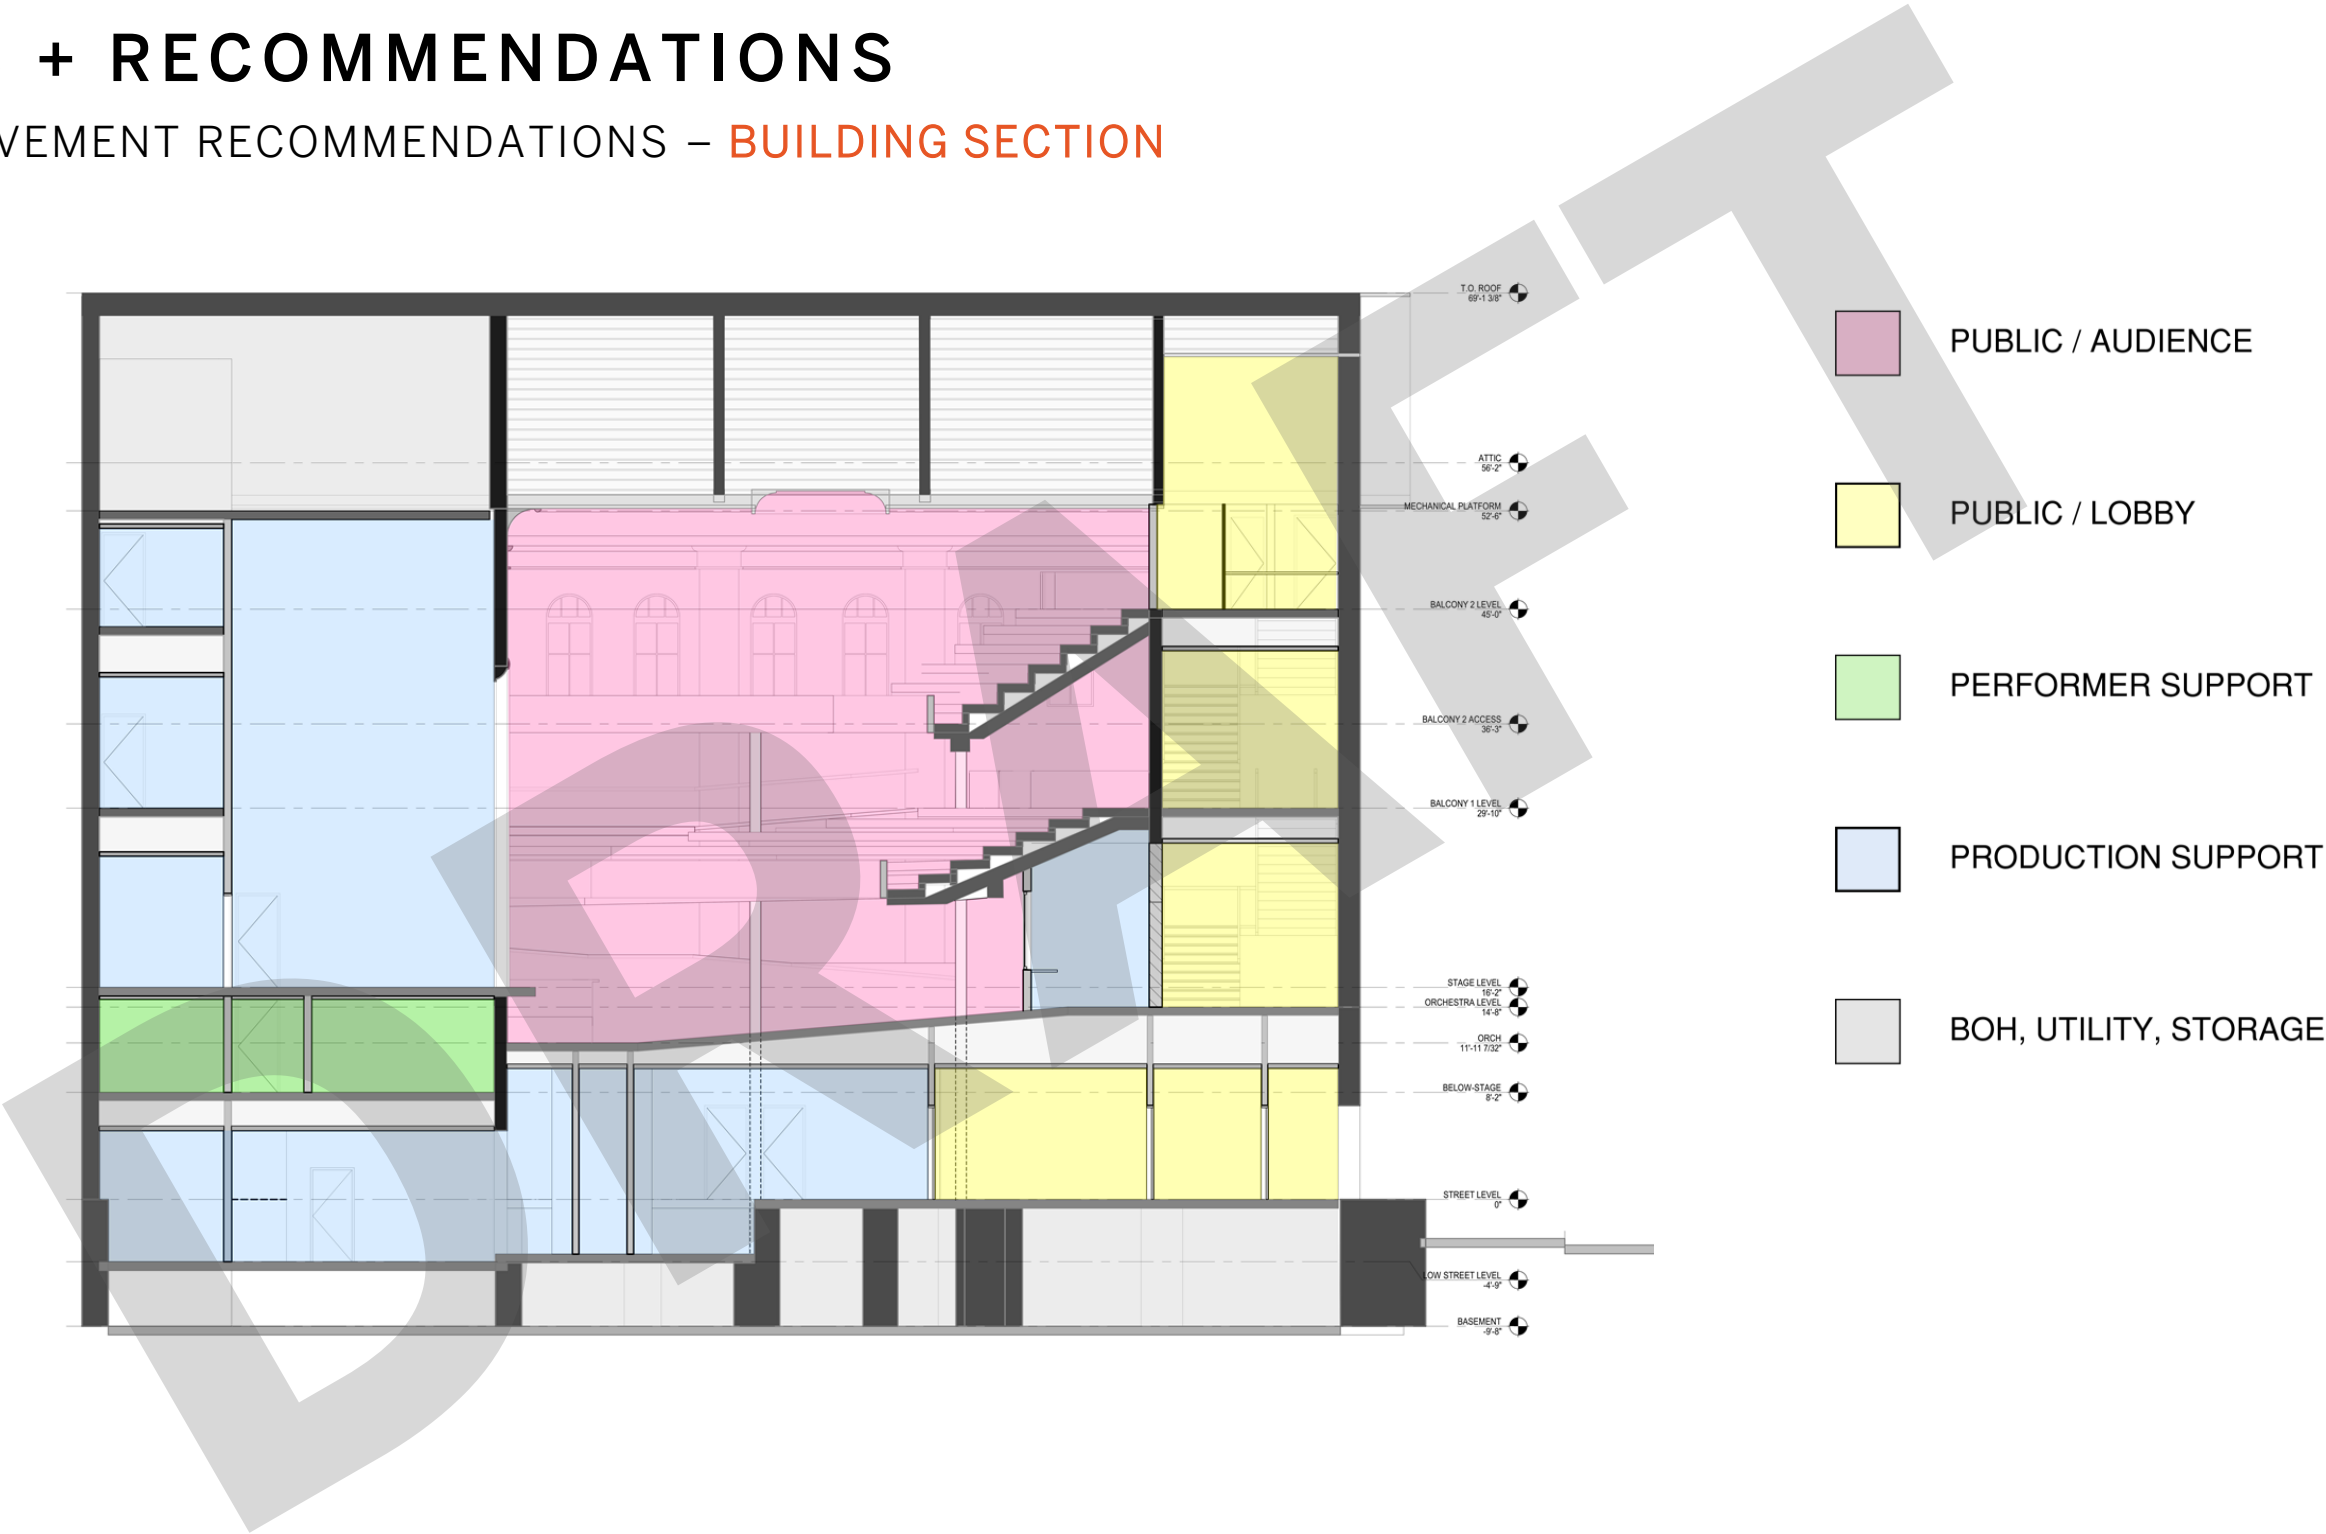
CAPITAL IMPROVEMENT RECOMMENDATIONS – BUILDING SECTION

EXISTING STAGE

WOOD GALLERIES & GRID

NEW STEEL STRUCTURE AND FOUNDATION SYSTEMS

- FULL STEEL GRIDIRON AND GALLERY STRUCTURE.
- NEW STEEL BEAMS THROUGHOUT.
- NEW STEEL COLUMNS FROM GRID LEVEL DOWN TO NEW FOUNDATIONS.

- FULL STEEL GRIDIRON AND GALLERY STRUCTURE.
- NEW STEEL BEAMS THROUGHOUT.
- NEW STEEL COLUMNS FROM GRID LEVEL DOWN TO NEW FOUNDATIONS.
- NEW 2-HOUR FIRE-RATED PROSCENIUM WALL FROM FOUNDATIONS TO ROOF.
- NEW FIRE-CURTAIN SEPARATING STAGE FROM AUDIENCE.
- STAGE SMOKE EVACUATION

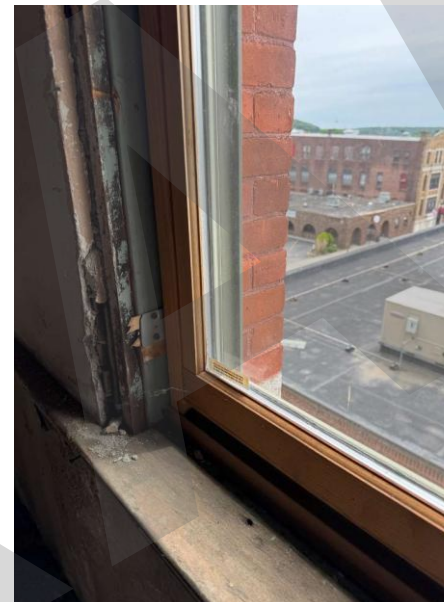
Fig. 3

From the standpoint of sound isolation, the existing theater structure appears to have at least one solid layer of masonry/stucco between the interior and exterior (Fig. 3). This provides a good foundation for sound isolation from exterior noise, given the relatively low levels of traffic noise outside the theater. Even with the extensive quantity of glazed surfaces open to the auditorium (Fig. 4), relatively little traffic was noticeable during our visit, with the exception of a couple louder motorcycles.

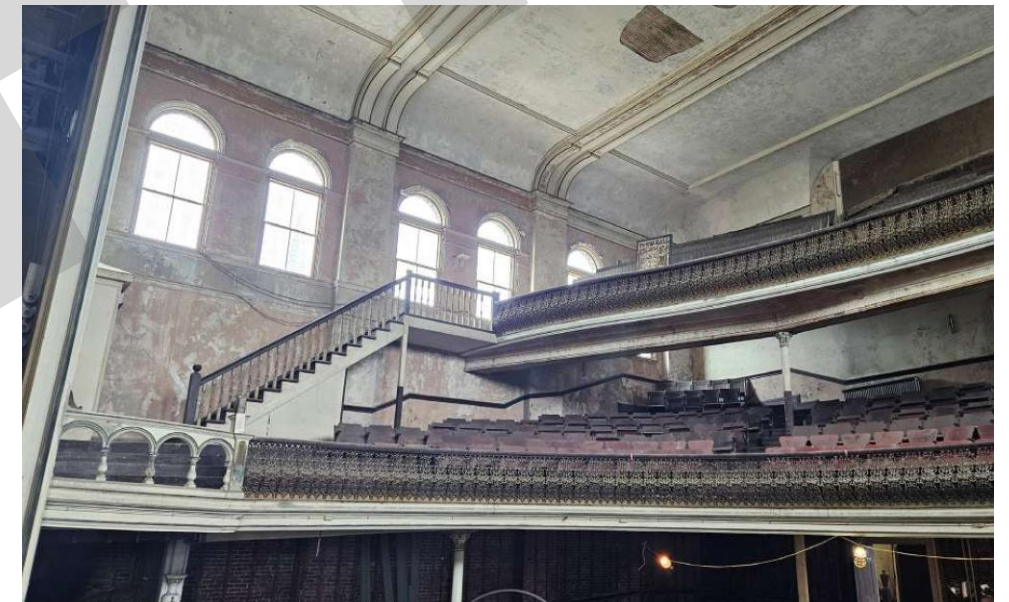
Fig. 4

We do, however, have concerns that any highly amplified events would be clearly audible outside the building and potentially disturbing to neighbors unless there are significant enhancements made to the windows and possibly the attic/roof assembly. Double or triple-glazed windows (if acceptable from a historic preservation viewpoint) would help contain most intelligible sound from amplified performances, though a series of acoustic shutters may be required within the auditorium to more fully contain bass frequencies. The attic zone would need to be sealed (or baffled if used as a plenum) to sufficiently isolate amplified performance sound levels.

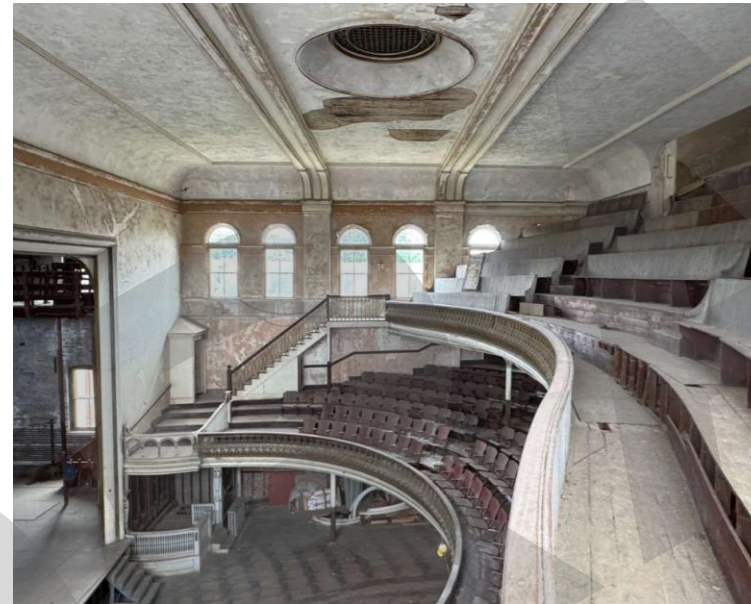
Fig. 6

The building does not appear to have any forced air ventilation. We assume that the heating was provided by steam or hot water, based on the presence of radiators within occupied areas (Fig. 5). Natural ventilation through windows and the attic void (Fig. 6) appears to be the traditional approach for cooling, and was likely satisfactory to audiences of the past century and neighbors who were not subjected to highly amplified performances. Modern comfort standards and the higher sound levels of today's amplified events will most likely lead the team to recommend some form of forced air cooling system with ducted fresh air intake and exhaust. Locating the equipment for these systems - most likely two or more air handlers plus chillers, pumps, and cooling towers - is an acoustical challenge. To the extent possible, these systems are best located in the basement or at grade and mounted on spring and neoprene vibration isolators.
